Australia's National
Science Agency

Air Infiltration of New Dwellings in Australia

Michael Ambrose and Sean Maxwell

June 2024

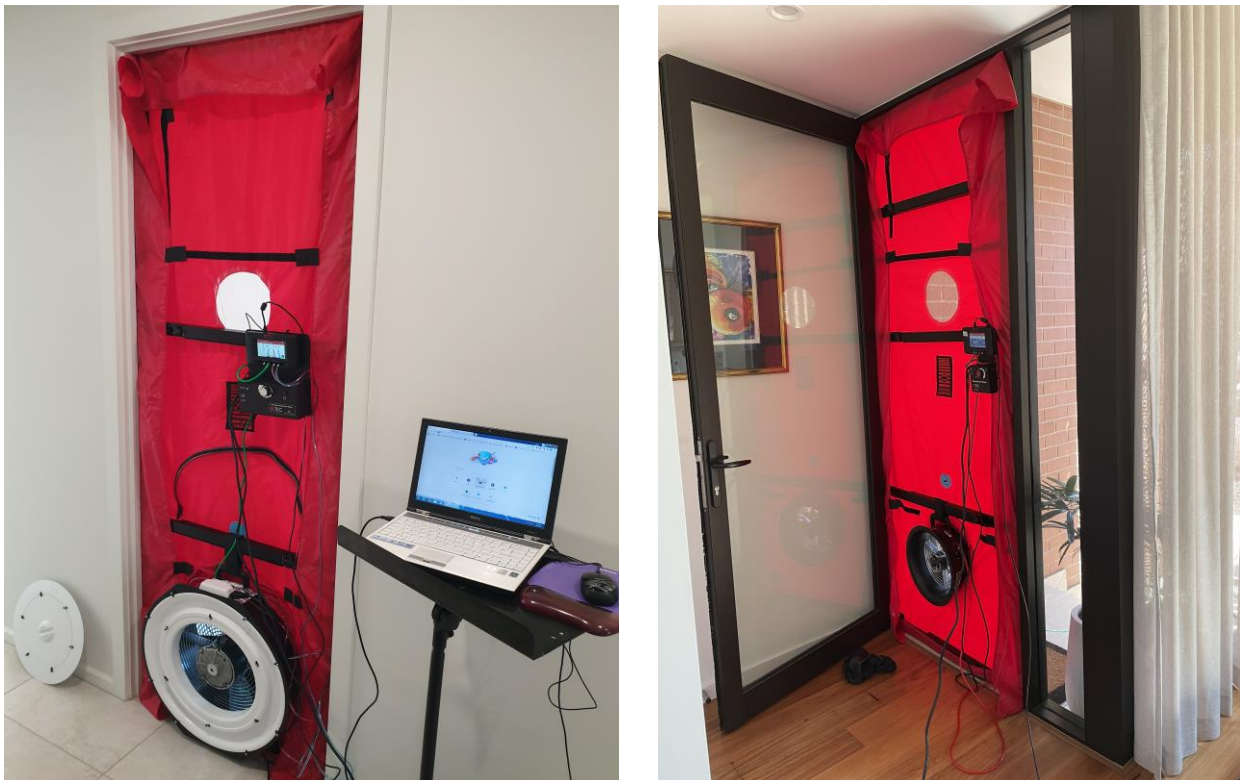
Figure 5 Typical air tightness setup

Consequently, for more direct applicability to Australian regulation and the NCC, Air Permeability (qE_{50}) is the measurement that has been utilised for this study. All tests were undertaken by ATTMA registered and qualified testers following the ATTMA Technical Standard TSL1, which is based on ISO 9972. All dwellings had both a pressurisation (positive pressure/air in) test and a depressurisation (negative pressure/air out) test.

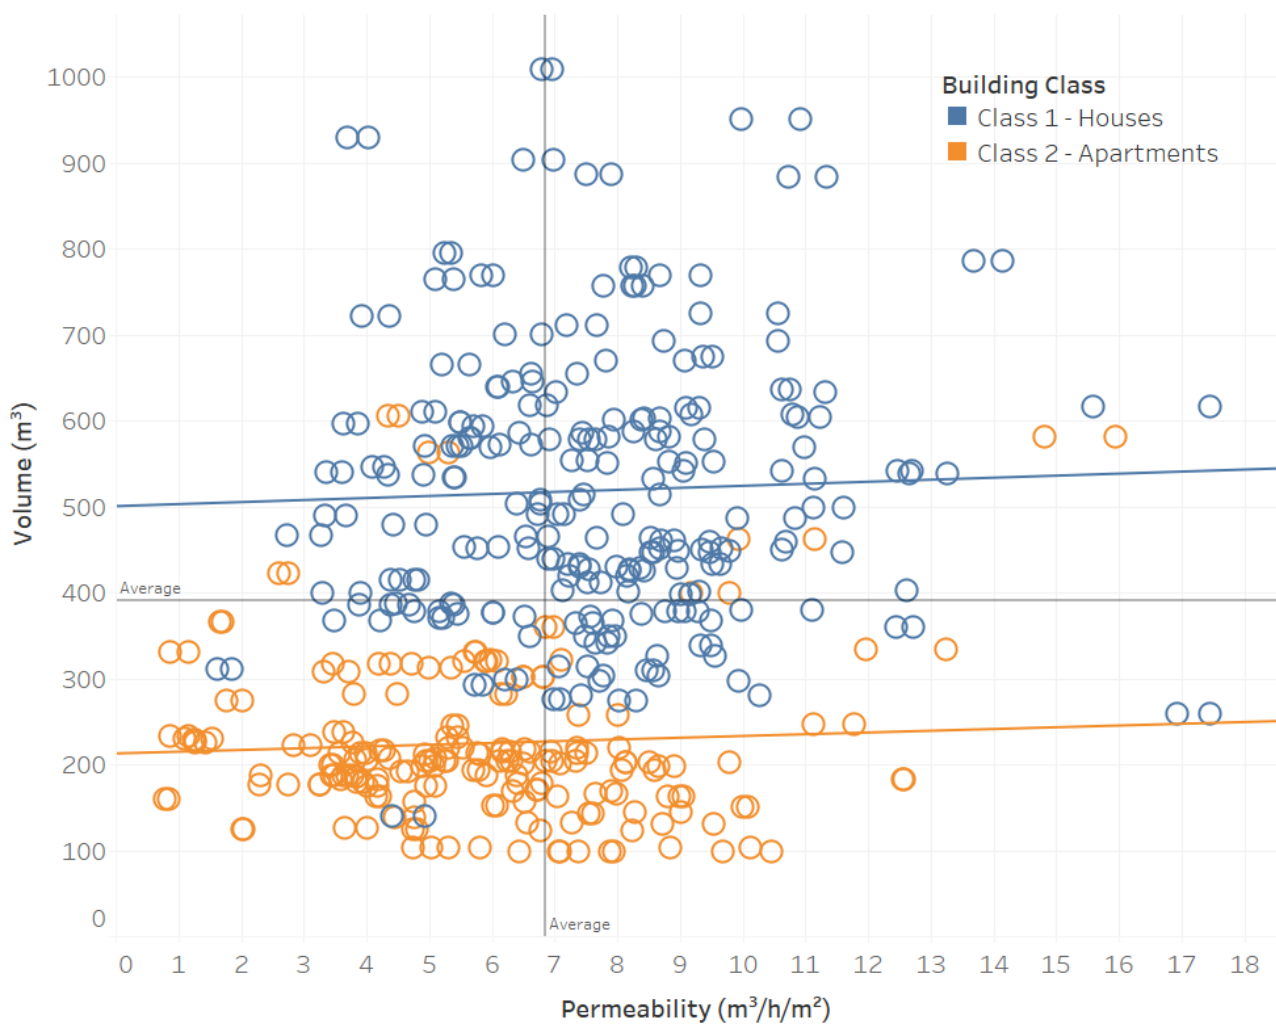
However, closer examination of the results obtained show that a correlation between air permeability and building size was not actually present. Figure 6 shows the plot of dwelling volume to their two air permeability tests. A linear trend has also been plotted for both dwelling classes. Although the overall trend was positive the R-squared value is below 0.1 for both, meaning that no correlation exists. This result was surprising and unexpected. The results suggest that the variability we see in air permeability rates is due to factors unrelated to the size of the dwelling. This might suggest build quality issues or the way penetrations in the building envelope are dealt with that can affect the air tightness of a dwelling rather than volume. Penetrations can include light fittings, power outlets, exhaust fans and ductwork for air conditioning systems.

Figure 6 Permeability to dwelling volume

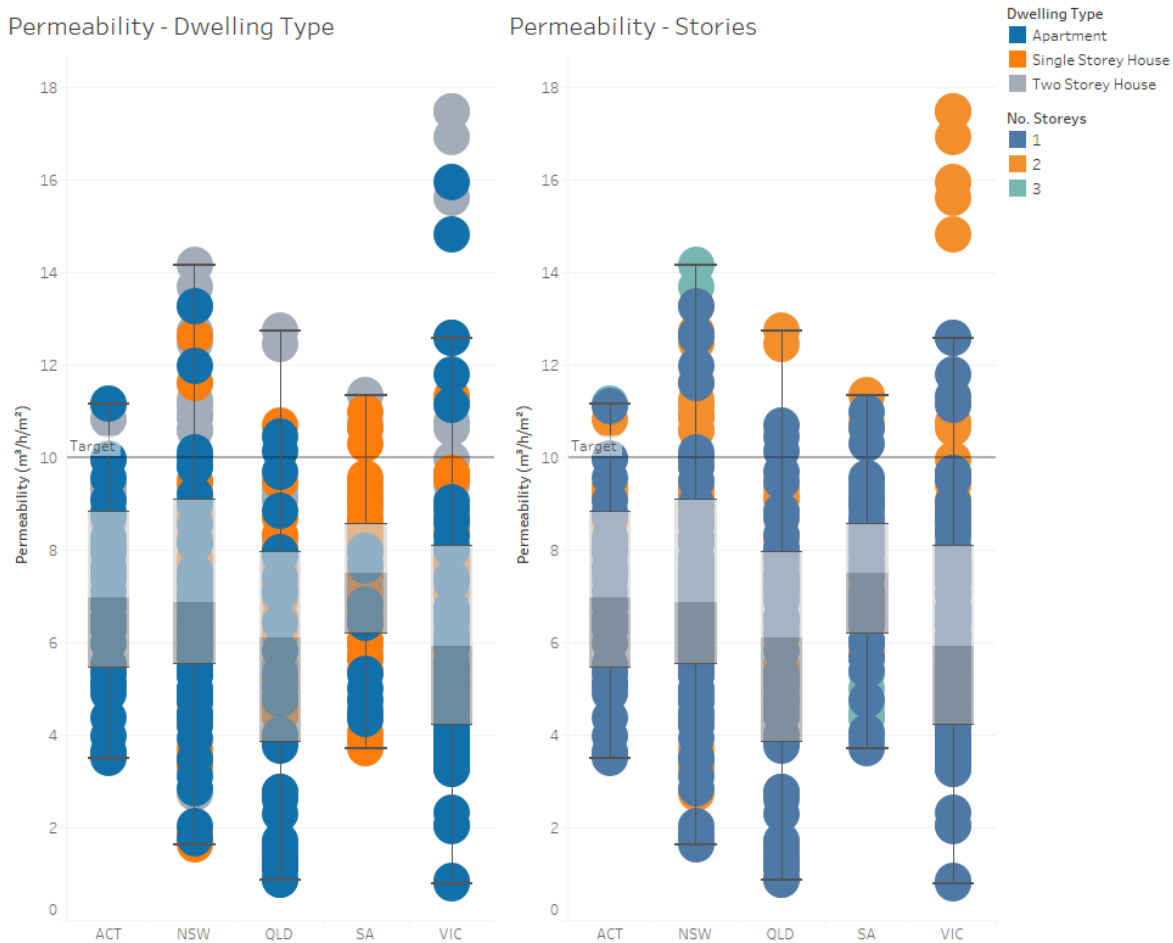
For this project a target qE_{50} of 10 m³/h/m² was selected. This is the threshold cited in NCC 2022 V2H6V3 as the performance requirement for dwellings seeking compliance through the performance provisions of the building code. Using the average permeability of each dwelling, this target was exceeded by only 9.7% of dwellings (11.7% of Class 1 and 7.1% of Class 2). Considering that most dwellings in Australia use the NatHERS provisions in the NCC, rather than the performance provisions, as the compliance pathway, it is encouraging that 90.3% of dwellings achieved the performance requirement. This demonstrates that the current performance requirement is achievable for NatHERS assessments and allows scope for future tightening of this requirement.

Figure 7 Permeability results for all dwellings by region

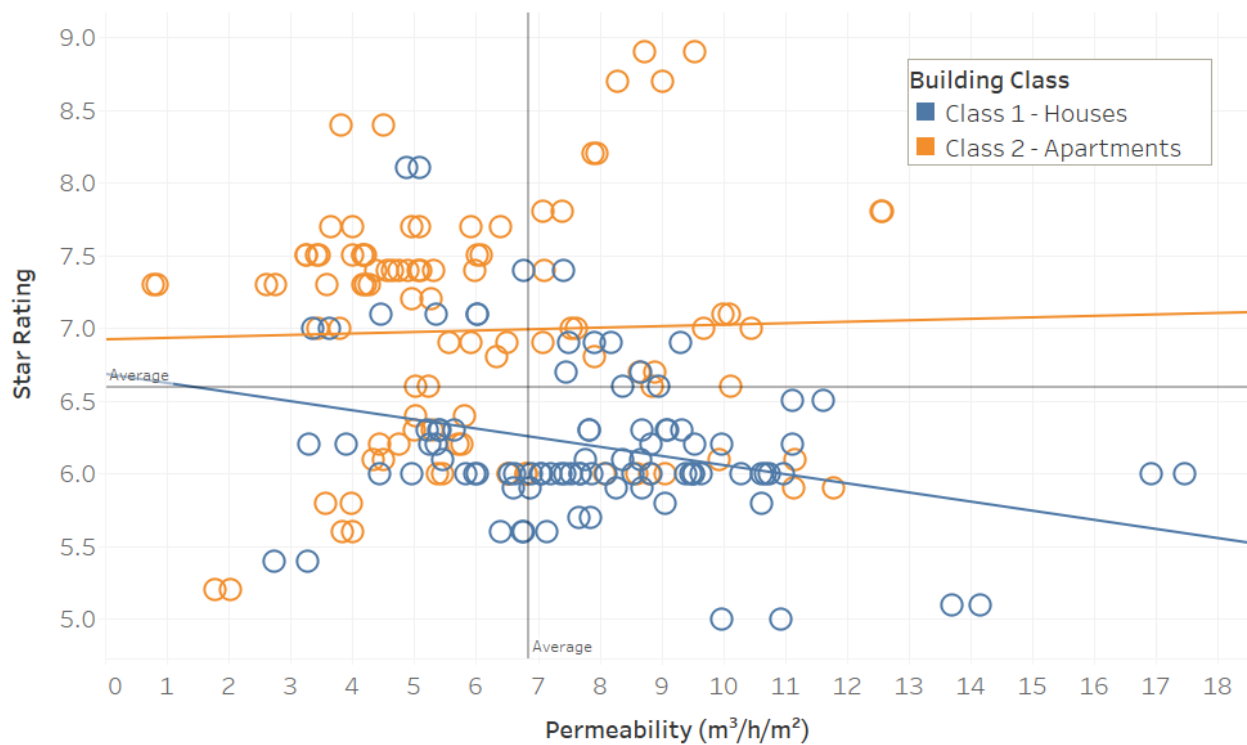
Figure 8 shows the plot of air permeability to NatHERS rating as well as the trend lines for the two building classes. It demonstrates that no correlation exists between the star rating and the air permeability being achieved. Although the class 1 trend line does trend in the expected direction, that is, as star ratings increase the air permeability decreases, the R-squared is below 0.1. For class 2 dwellings the trend line is virtually flat. Indeed, the highest star rated dwelling was an apartment that rated at 8.9 stars and it returned an average qE_{50} of $9.1 \text{ m}^3/\text{h}/\text{m}^2$ which is above the overall apartment average of $5.8 \text{ m}^3/\text{h}/\text{m}^2$ and also above the average qE_{50} of $6.9 \text{ m}^3/\text{h}/\text{m}^2$ that was achieved for all the dwellings that the study found star ratings for. The dwelling with the lowest qE_{50} of $0.8 \text{ m}^3/\text{h}/\text{m}^2$ was an apartment that achieved a star rating of 7.3 stars.

Figure 8 Permeability to star rating

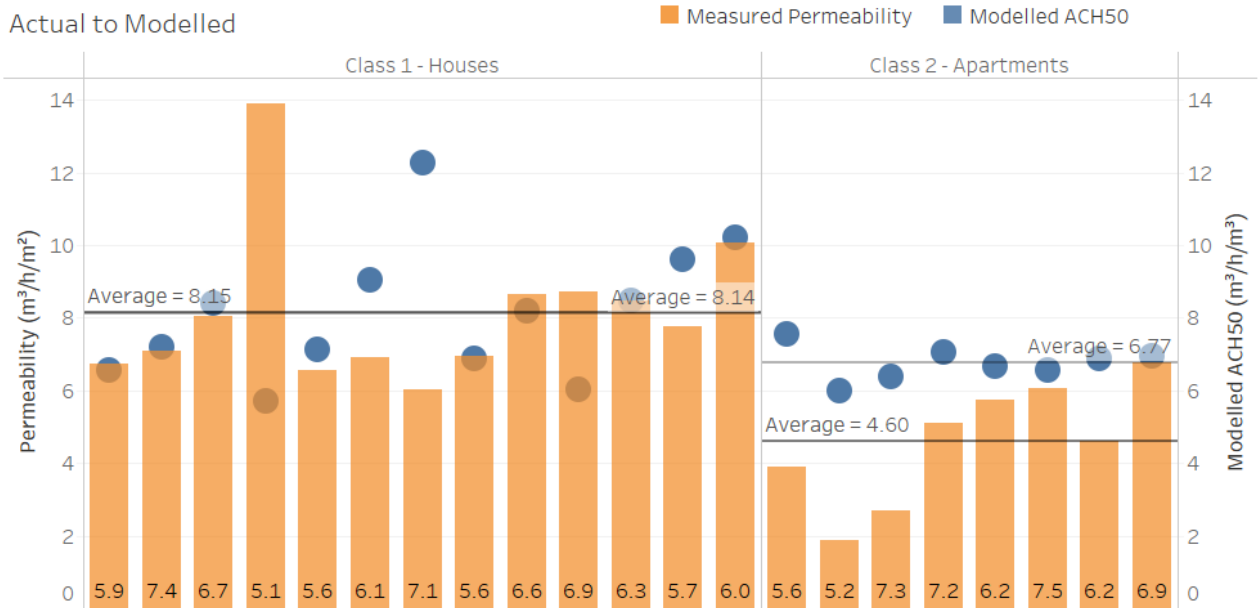
Overall, this analysis shows that the assumed air tightness values used in the NatHERS design modelling correlate well with the actual measured permeability of the built dwelling, particularly with Class 1 dwellings.

Figure 9 Measured permeability to modelled air change rate

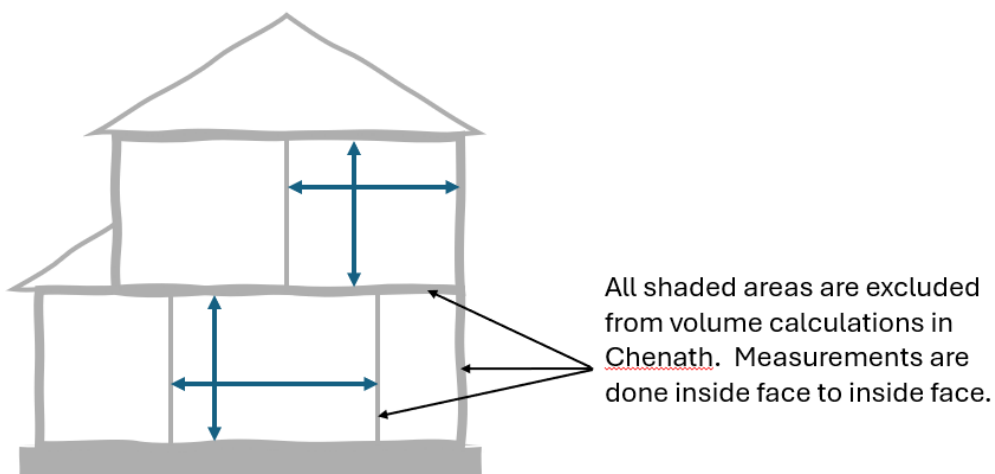
In Chenath, the calculations for the volumes are done from inside face to inside face of individual rooms (Figure 10). Consequently, the volume of walls separating internal zones are excluded for the air permeability calculations (Figure 10, 27). Likewise, the surface areas of the intersections of those interior walls with exterior floors, walls, and ceiling are also excluded. Lastly, the volume and surface area of inter-floor spaces on multi-story dwellings is also ignored (Figure 12).

Figure 10 Cross section of house showing Chenath measurement approach

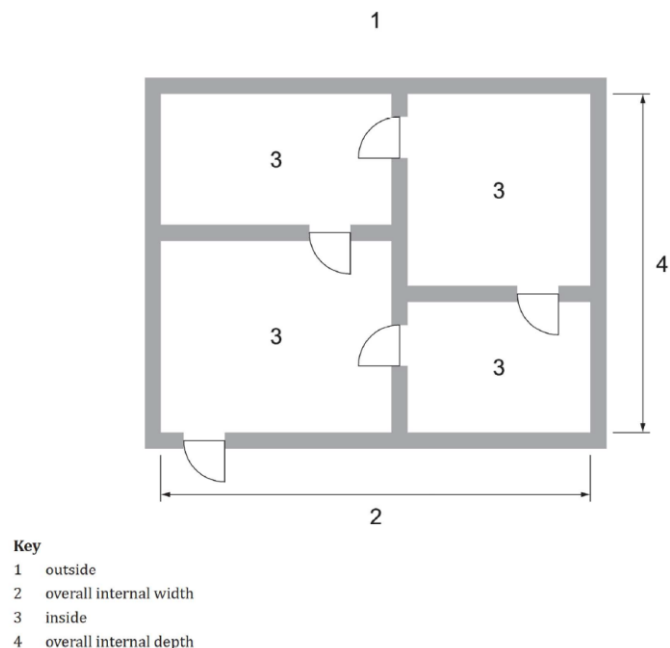
This differs from a straightforward application of the calculation method suggested by ISO 9972:2015 section 6.1 (Figure 11). This method is simpler in comparison to the Chenath engine’s calculations and includes any internal volumes and their intersections with the exterior surface.

Figure 11 Overall internal dimension of plan

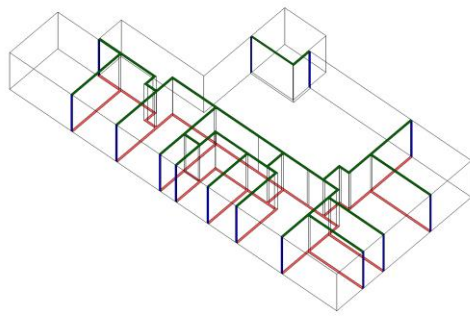
Figure 12 shows the areas of difference schematically. Clear wireframe shows the general outline of a building envelope, while coloured areas highlight differences between ISO 9972:2015 and NatHERS. Blue lines show the difference resulting from inclusion of interior walls with exterior walls. Green lines show the difference resulting from the inclusion of interior walls with exterior ceilings. Bright pink areas show the difference resulting from the inclusion of inter-floor spaces with exterior walls. The amount of difference depends on the geometry of a particular dwelling.

Single storey house

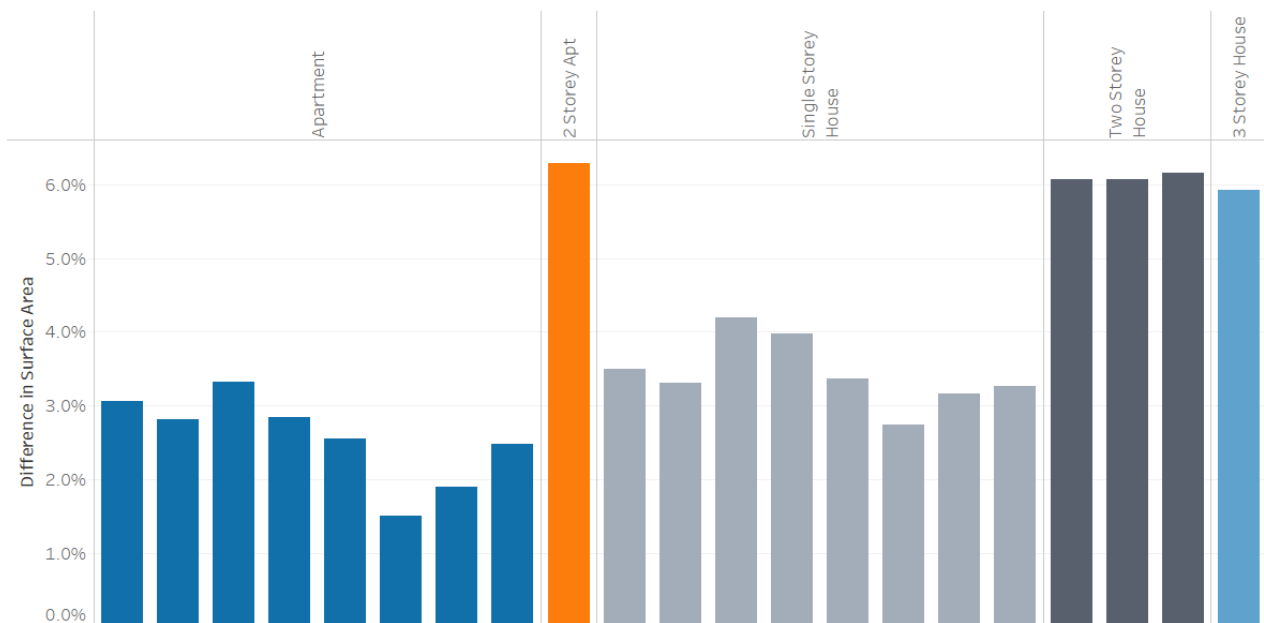
Overall, there is an average difference of 3.7% between the method suggested by ISO 9972:2015 and the NatHERS calculation method, with the NatHERS figures always being smaller. The difference was smaller for apartments and single-story houses, and greater for multi-story houses, from a minimum of 1.5% up to a maximum of 6.3%, see Figure 13. The sample size is small, and only one three-story house was calculated, but there is a clear, overall trend, which is mathematically rational. The main difference with multi-story dwellings is due to the presence of an inter-floor space.

Figure 13 Difference in surface area calculations by ISO 9972:2015 and NatHERS

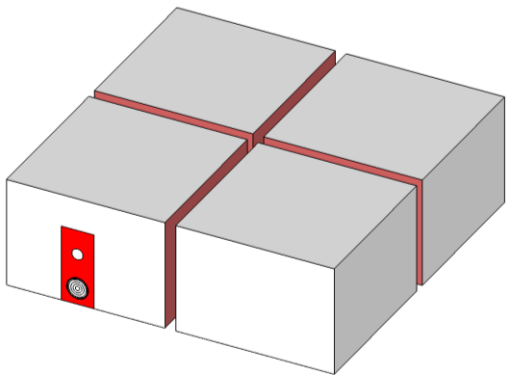
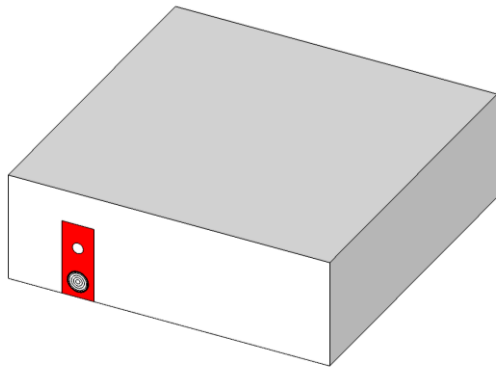
To express air permeability, an air tightness test result is divided by the dwelling’s surface area. As demonstrated above, the surface area in square meters resulting from the NatHERS method will usually be smaller, as it underestimates the total surface area of a dwelling than one resulting from the ISO 9972:2015 method. Therefore, the air permeability figure according to the NatHERS surface area calculation will be worse or leakier, than one divided by a surface area according to the ISO 9972:2015 method, see Figure 14.

Surface area by NatHERS practice: 485/ m ³	Surface area by ISO 9972:2015: 500 m ³
Blower door result: 2000 m ³ /hr @ 50 Pa	Blower door result: 2000 m ³ /hr @ 50 Pa
Calculated permeability: 4.12 m ³ /h.m ² @ 50 Pa	Calculated permeability: 4.0 m ³ /h.m ² @ 50 Pa

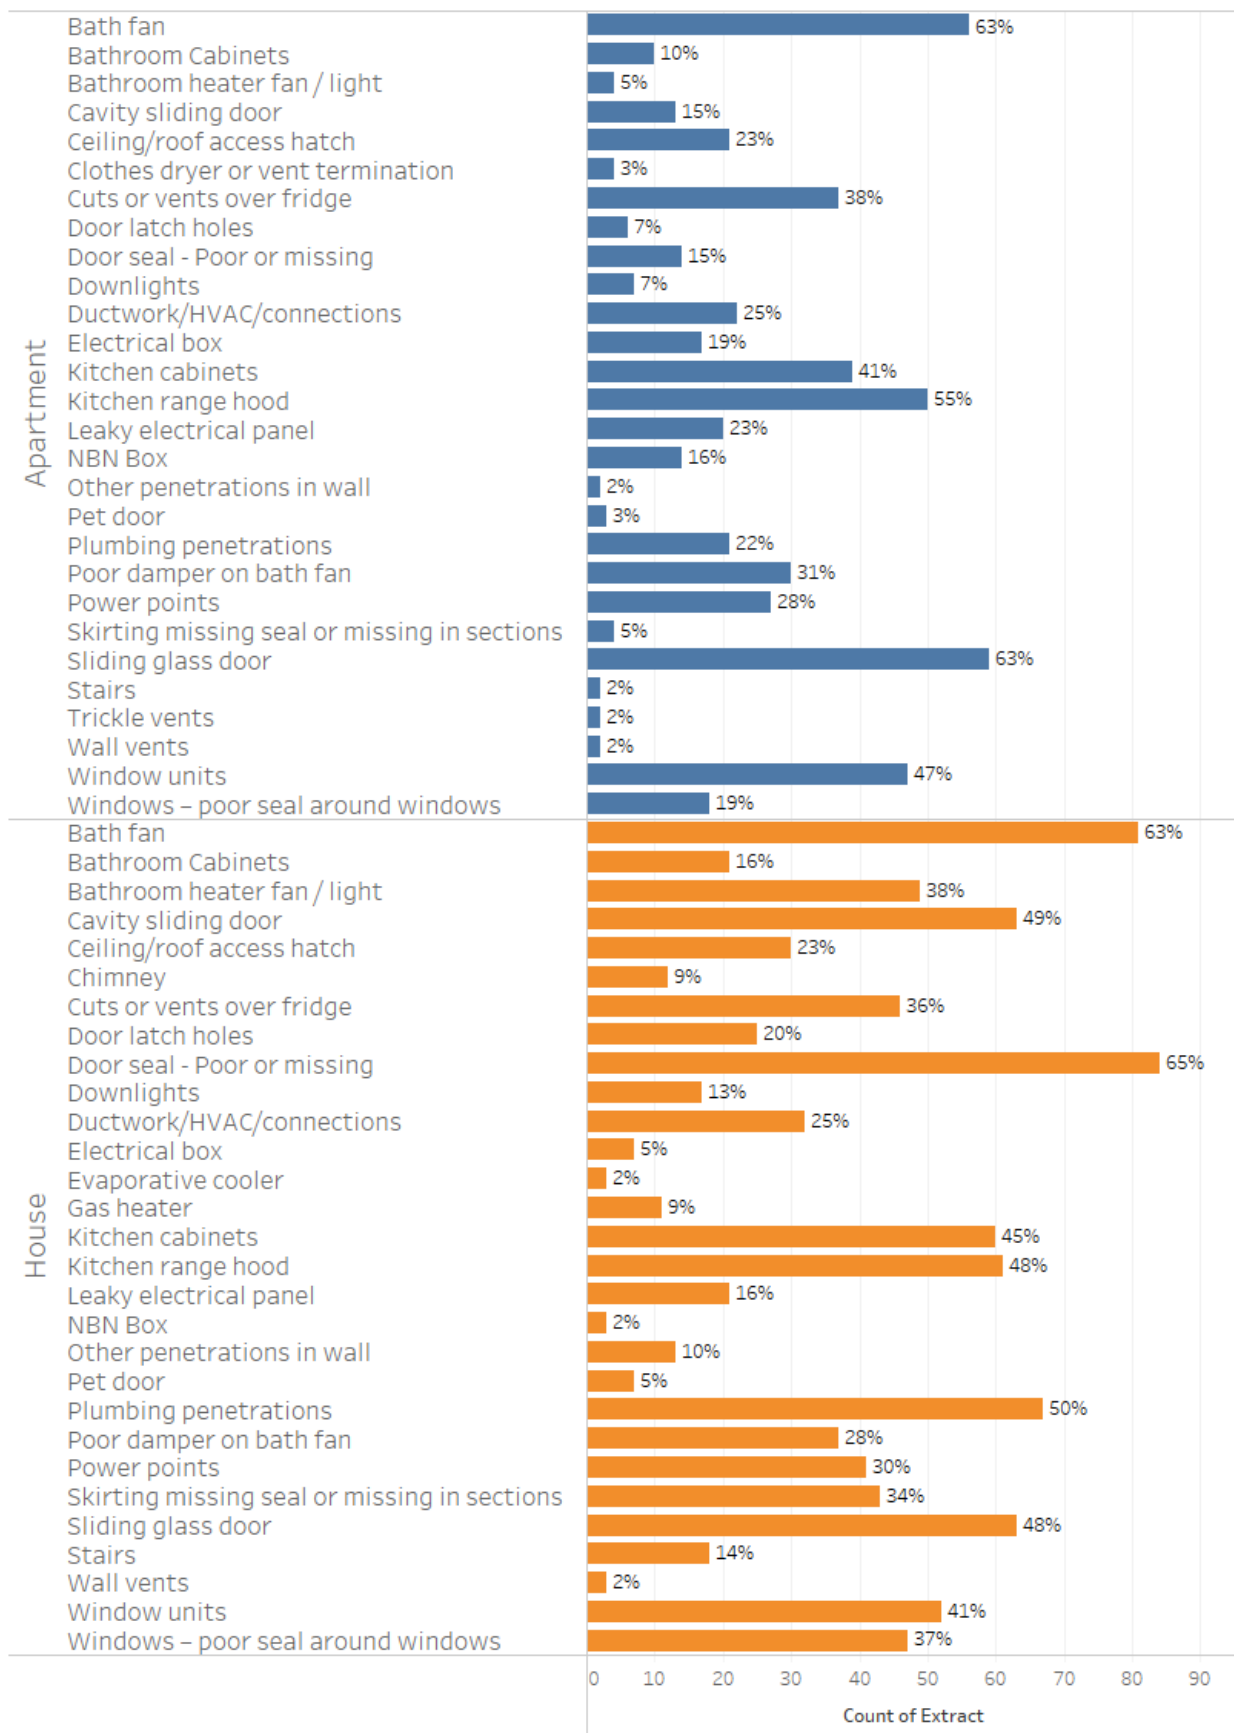
The most reported air leakage point for apartments (59 reports) was sliding glass doors with 63% of apartments having this issue. For most apartments the sliding door will usually lead to a balcony and is often the primary means of obtaining outside air and natural ventilation. These doors get high levels of use and consequently this can lead to damage of weather and door seals. Install quality and the quality of the door system itself can also lead to poor performance of the door over time. Sliding doors were also a major issue in houses (63 reports) with 48% of houses having this issue.

Figure 26 Identified leakage points

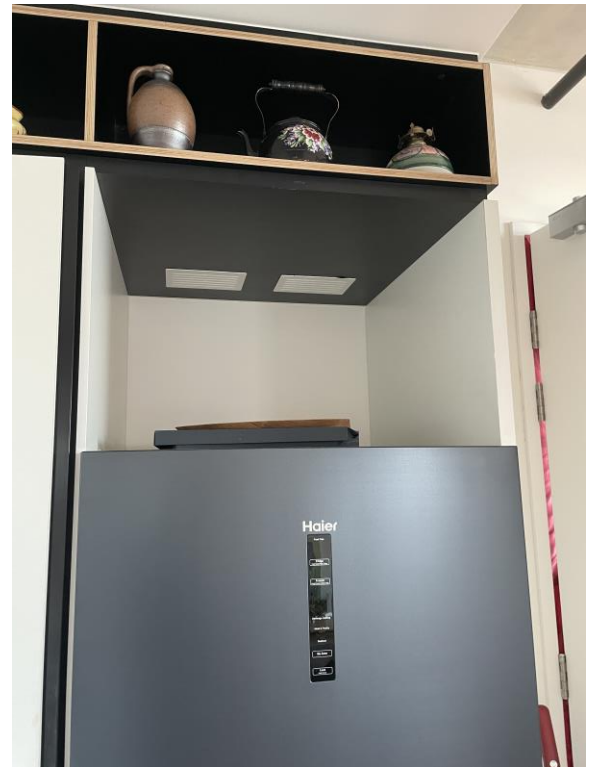
Internal cavity sliding door

Sliding glass door

Vent over fridge

Figure 27 Typical leakage points identified

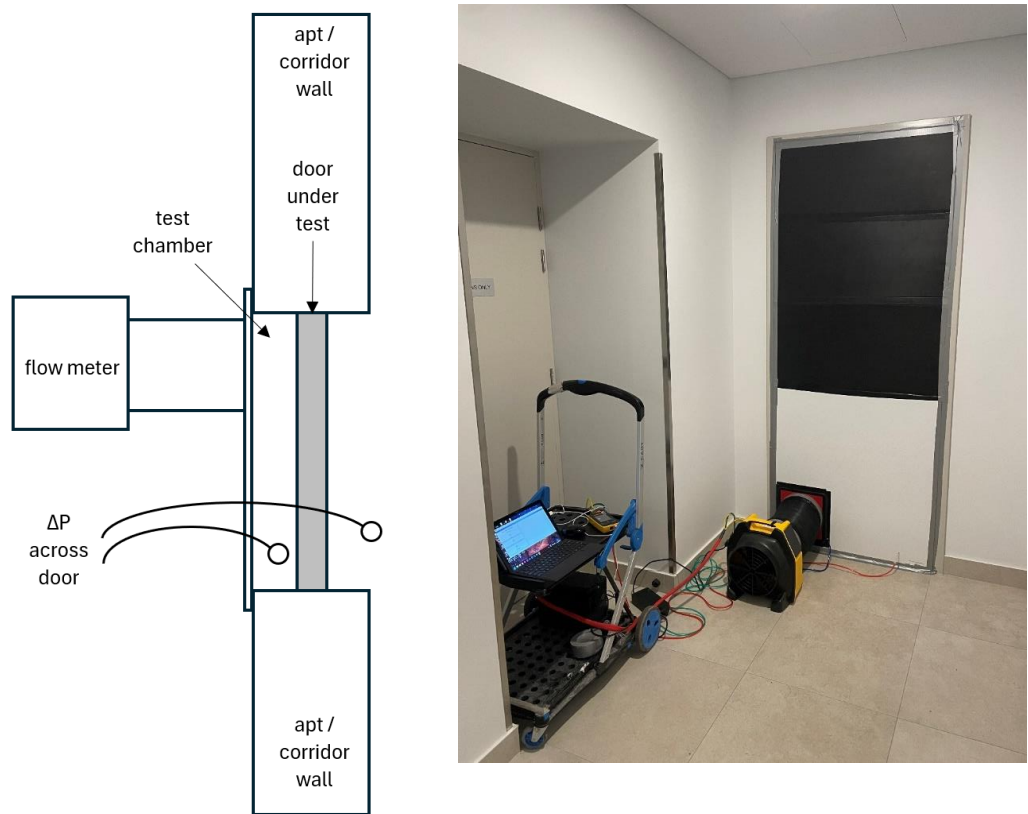
Above 15 Pascals, it can be seen that the door under test may be pushed away from its seals to the point that it possibly leaks more than in typical operation at lower pressures. For this reason, test pressures were generally capped at about 15 Pascals.

Figure 28 Door leakage test rig setup

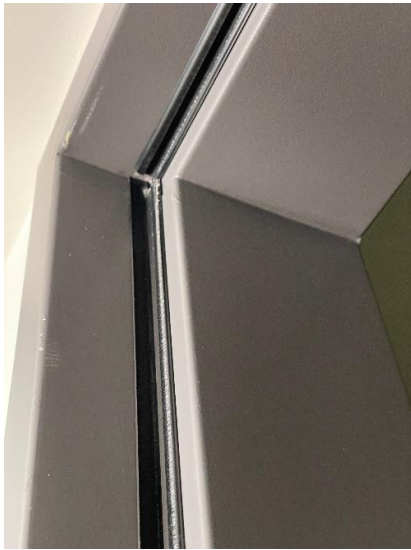
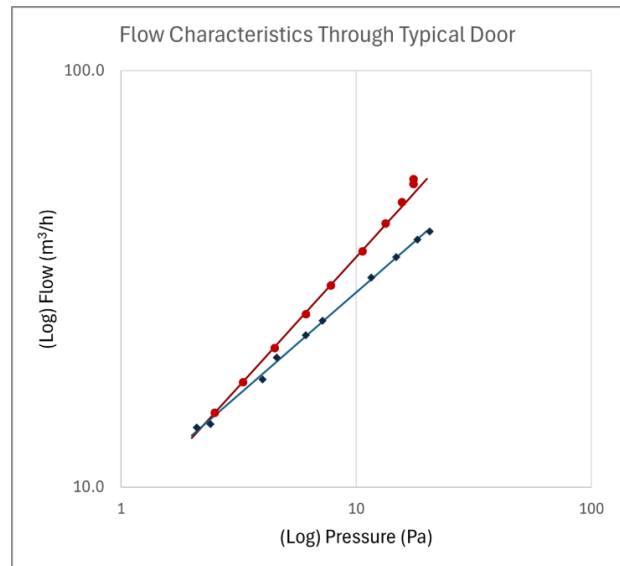
For these reasons, the tests were conducted under negative pressures and were generally capped at about 15 Pascals. Data was entered into Retrotec Fantestic software for calculation of a projected leakage rate at 50 Pascals for comparison.

Figure 29 Flow characteristics through typical door

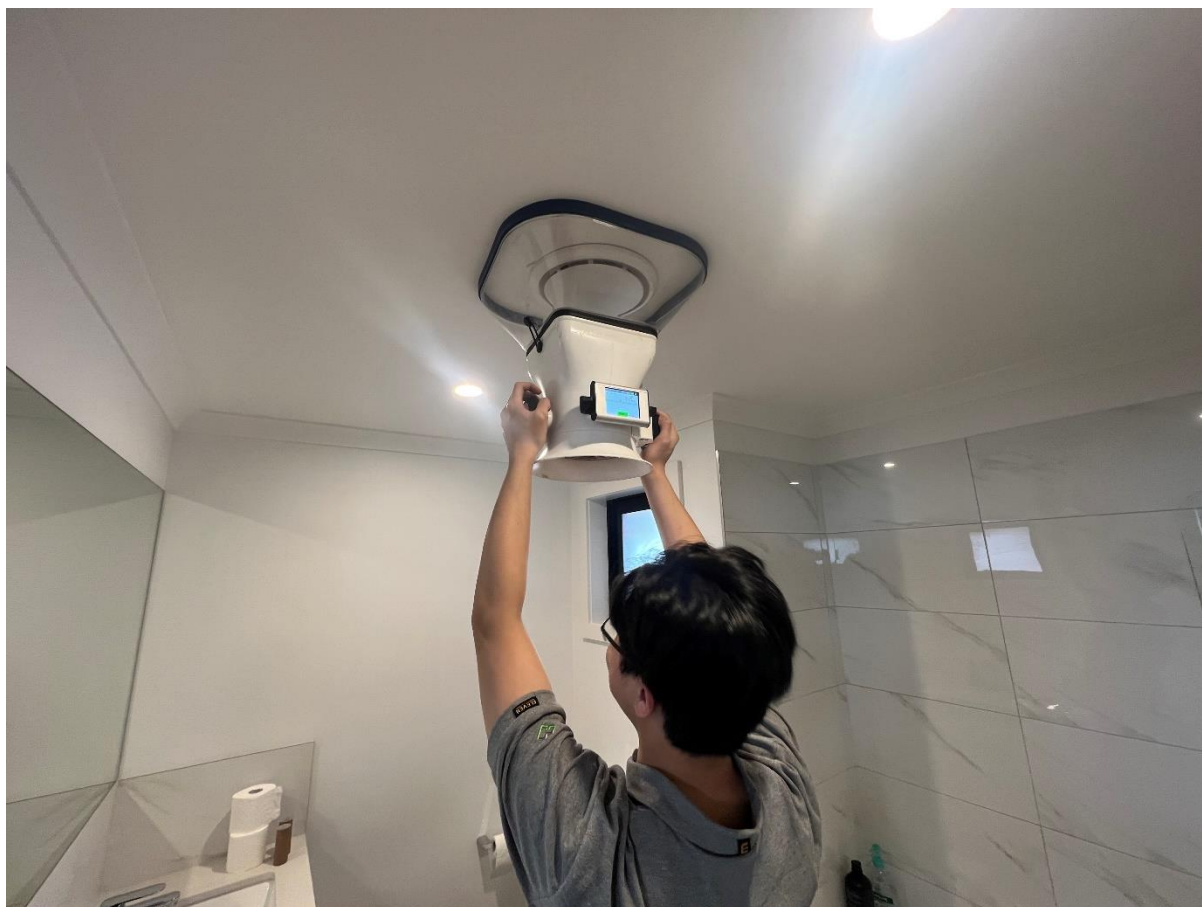
Measurements were made with fans in different operating modes. One was with the door to the zone open, and one with the door closed. This was to observe the effect that closing doors had on the performance of the system. For example, if bathrooms do not have sufficient door undercut or other gaps, they may be starved for pressure relief and may not function effectively. Flow rates were measured with doors open and closed, and pressure drop across the door was measured when closed. Finally, visual observation of the door undercut was made to estimate the size.

Figure 31 Measuring exhaust fan ventilation

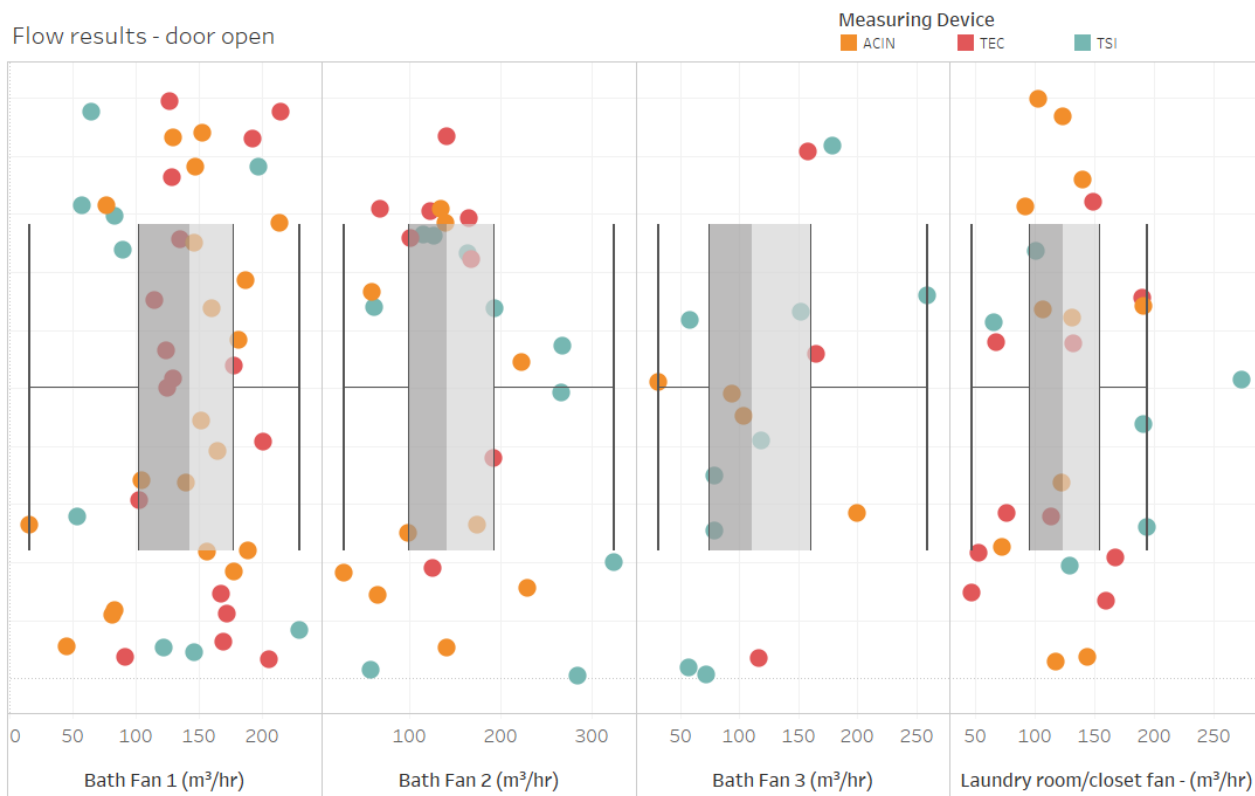
In total, airflow measurements were made from 121 different fan installations at 51 separate dwellings. Some were very large and drew large flow rates; others were small and drew much lower rates. The lowest measured flow was 16 m³/hr, but there were others that were likely lower. These lower rates could not be measured with the equipment on hand. Figure 32 shows a box and whisker plot of the flow results for exhaust fans in various locations all with the door to the zone being open. A range of measuring devices were used for the testing, these are noted on Figure 32.¹

Figure 32 Flow rates for exhaust fans with door open

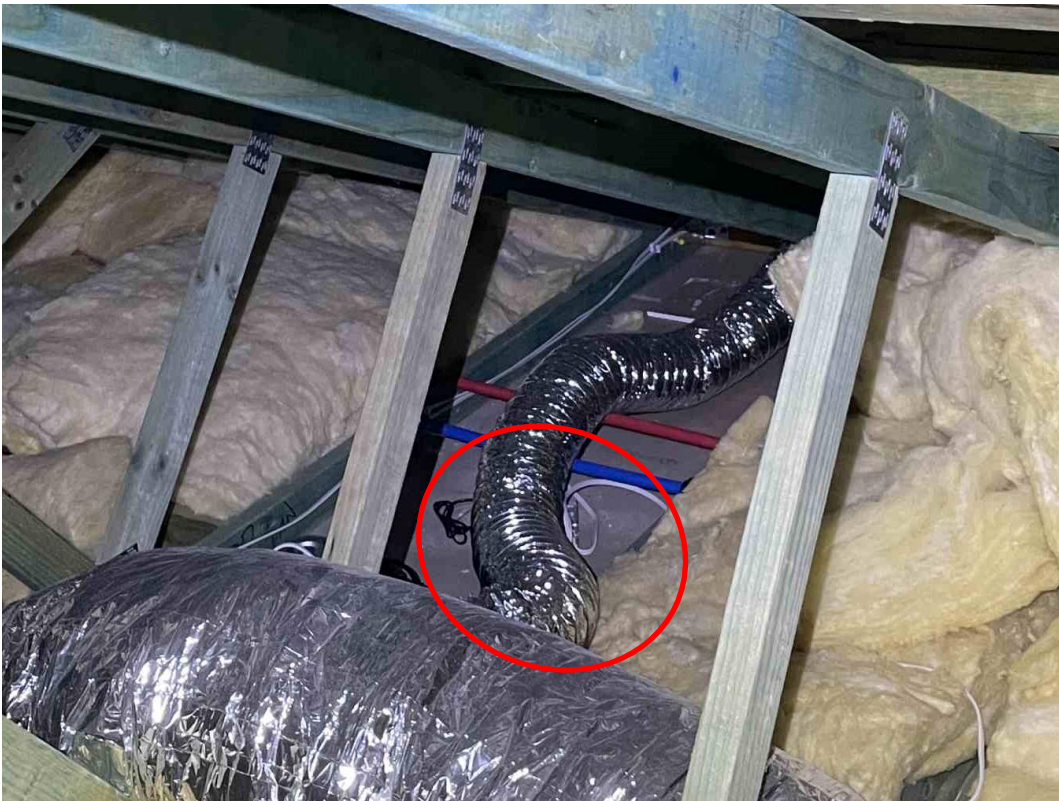
Some fan installations were subject to poor ductwork installation. In a few houses, some fans were performing normally, while a single fan was specifically low. Upon investigation in the roof space, it could be seen that the ductwork connected to the fan was longer than necessary, winding, and crimped in some areas, all contributing to lower airflow (Figure 34).

Figure 34 Crimped excess exhaust fan ductwork

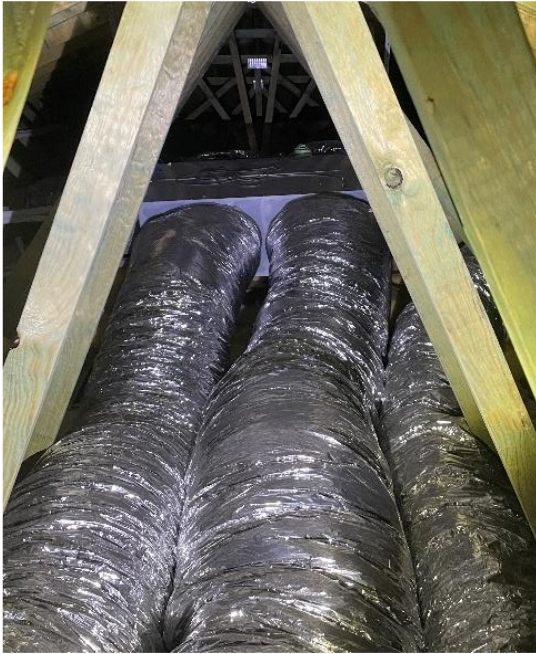
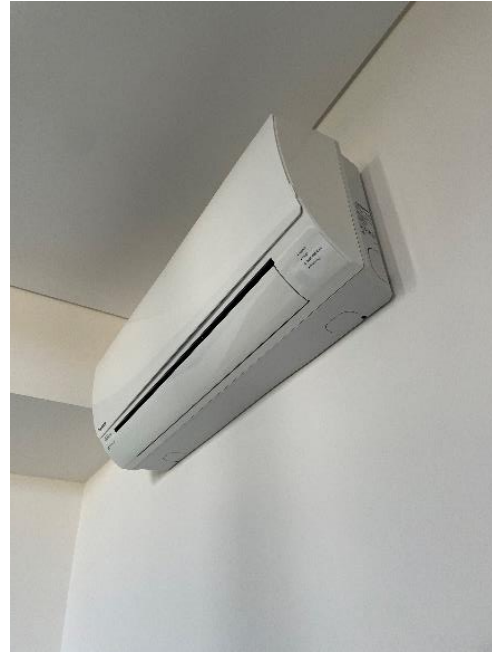
Any duct air leakage to an unconditioned space such as a roof space is a direct energy penalty. There is no possibility of recovering the energy spent on heating or cooling that air. However, when ductwork is located within the conditioned envelope the losses are lessened. An example is a wall surface-mounted split system. All air that passes through the system is directly recovered from the living space, and distribution losses are nil, see Figure 37.

Distribution entirely outside the conditioned envelope

Distribution entirely within the conditioned envelope

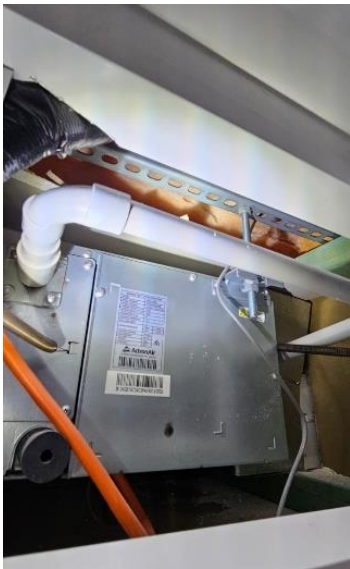
Insulation visible above unit, showing poor isolation

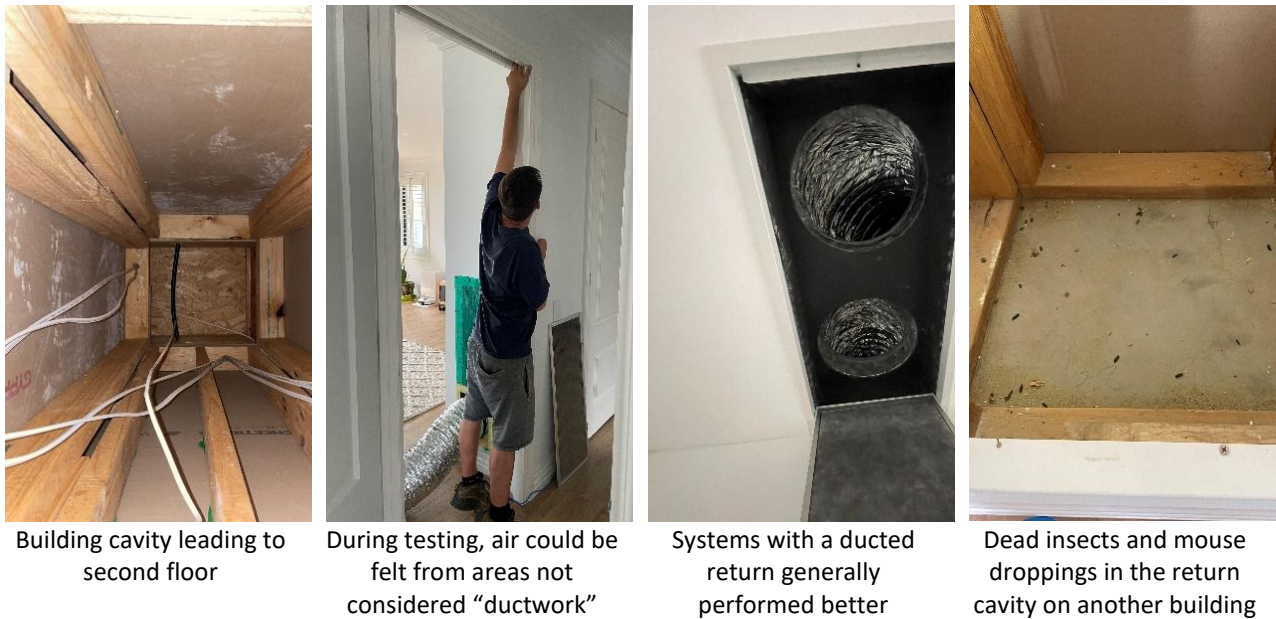
Figure 39 Ducting issues

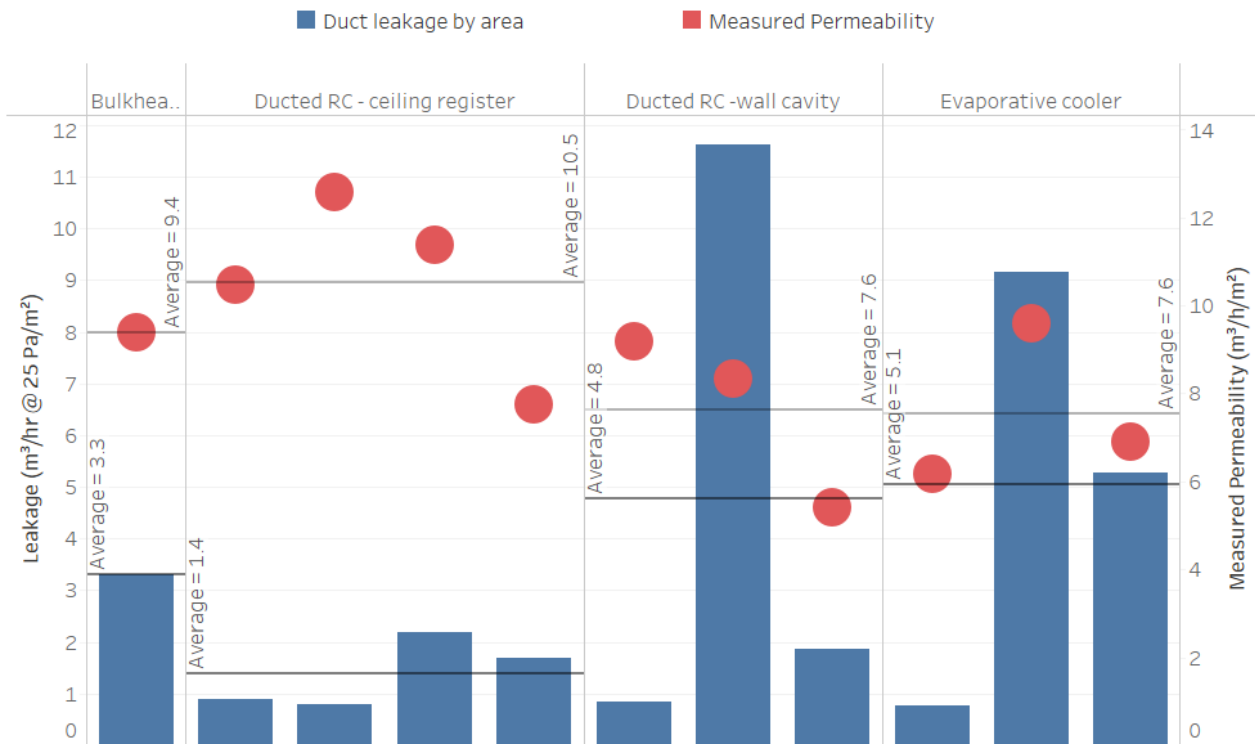
Figure 40 Duct leakage compared to dwelling permeability by HVAC system

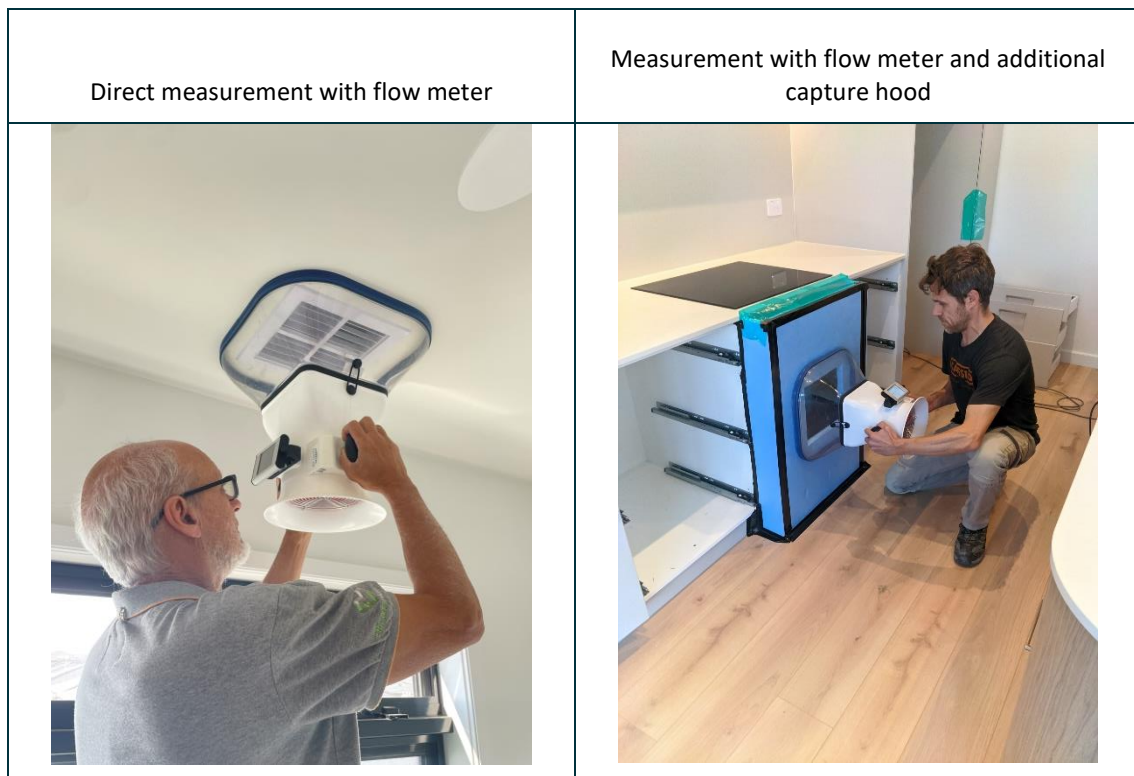
Figure 41 Examples of methods for undertaking individual component leakage testing

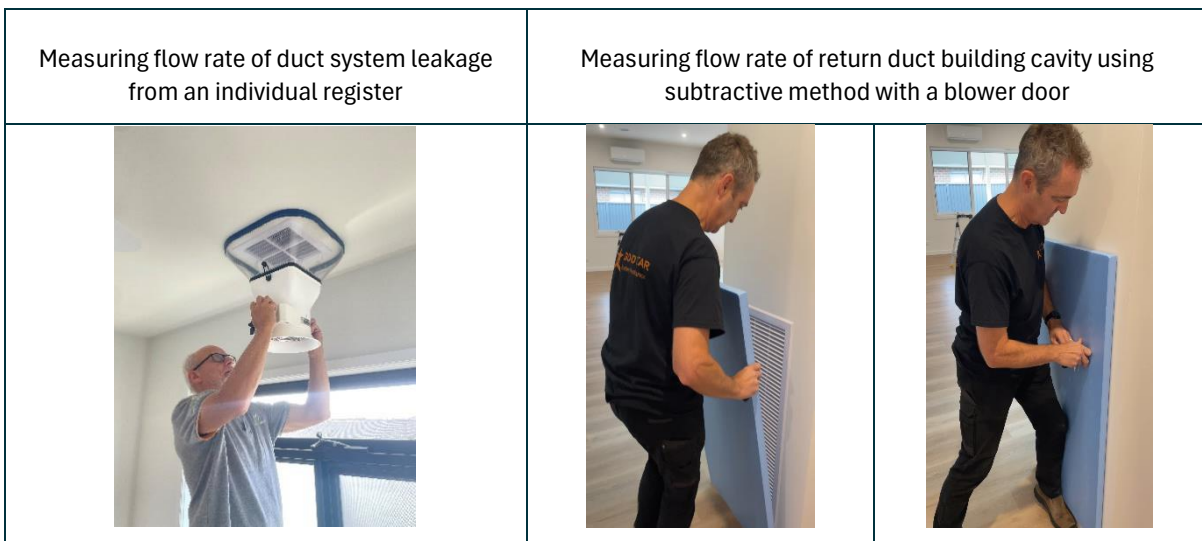
Figure 42 Measurement techniques for ducted systems

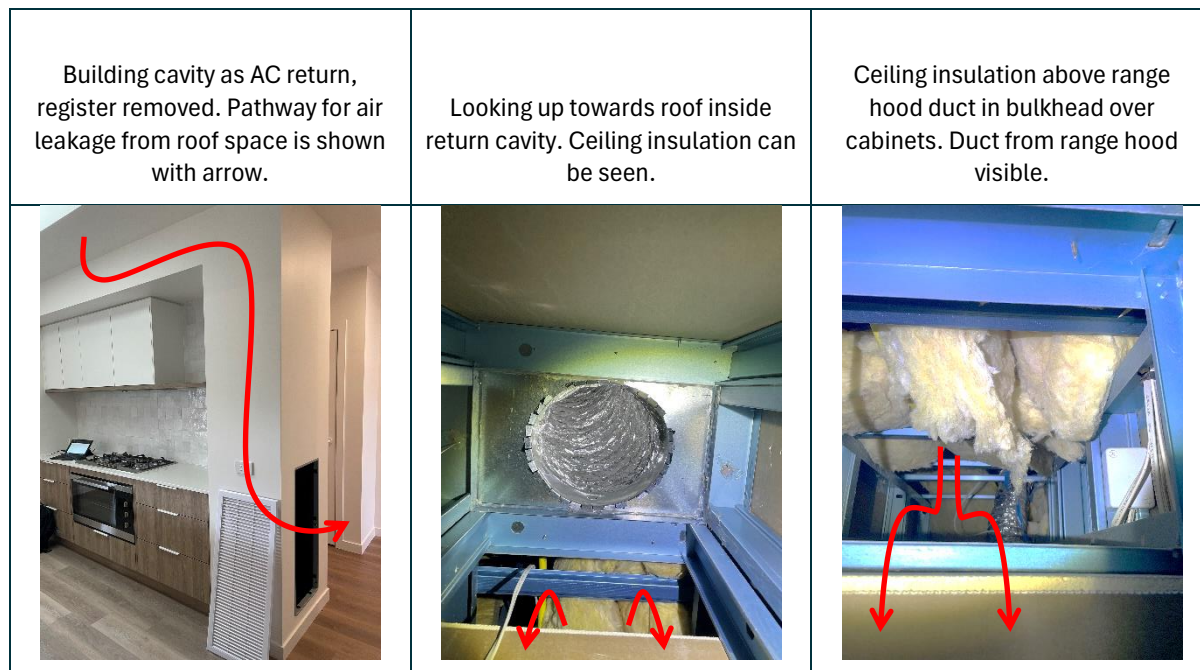
Figure 43 The use of building cavities as ductwork

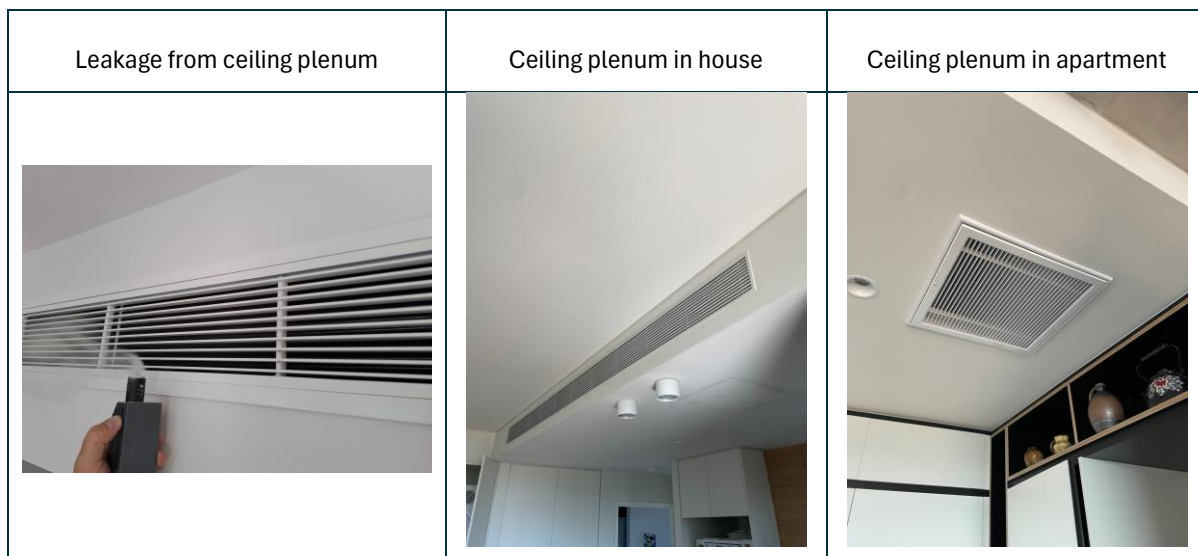
Figure 45 Ceiling plenums
