Australia's National
Science Agency

Air Infiltration of New Dwellings in Australia

Michael Ambrose and Sean Maxwell

June 2024

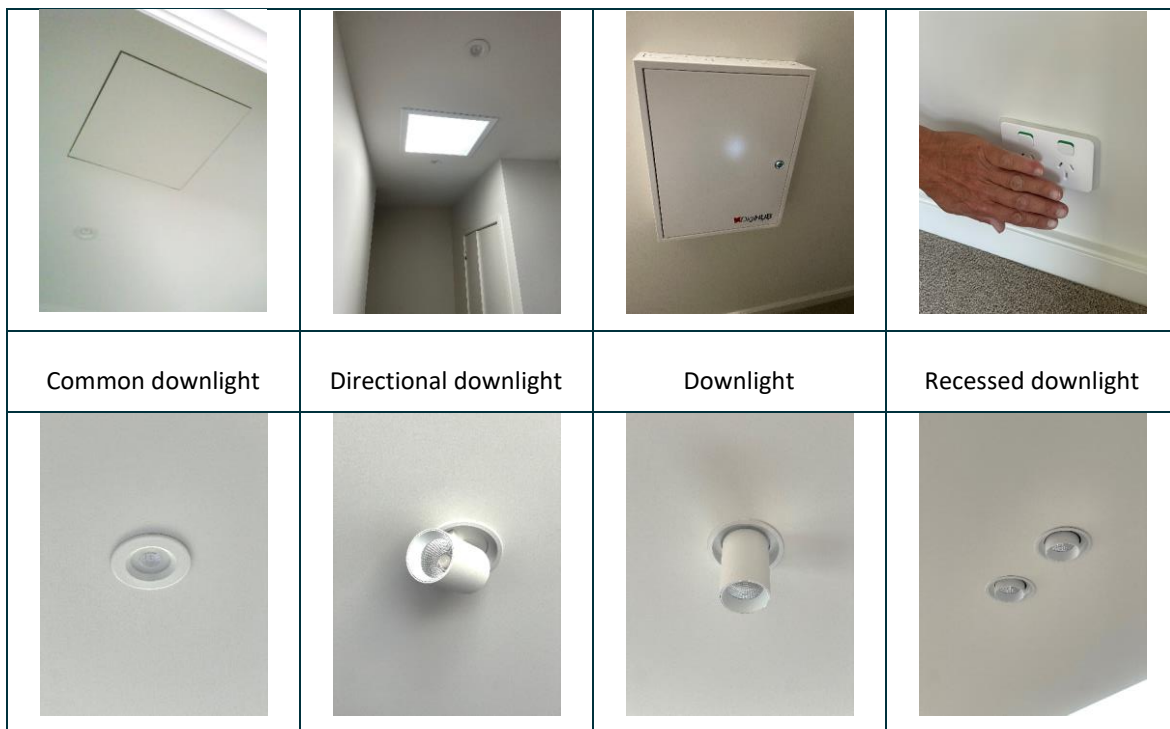
Figure 46 Examples of individual items measured directly by flow hood

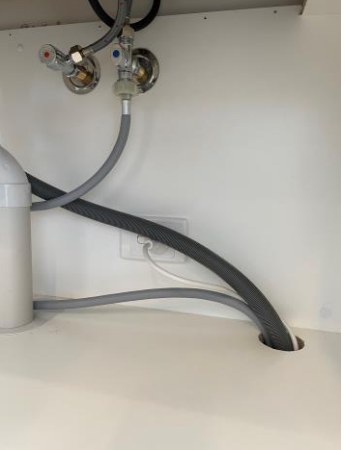
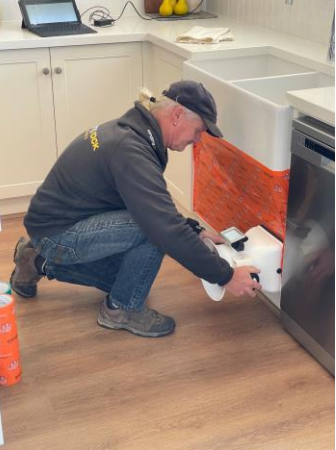
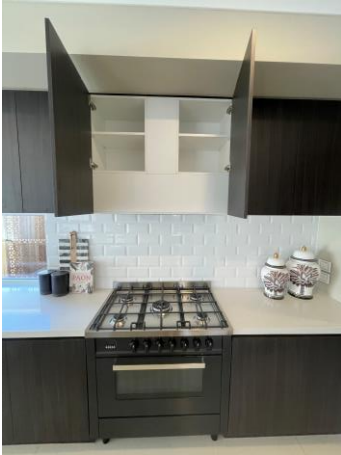
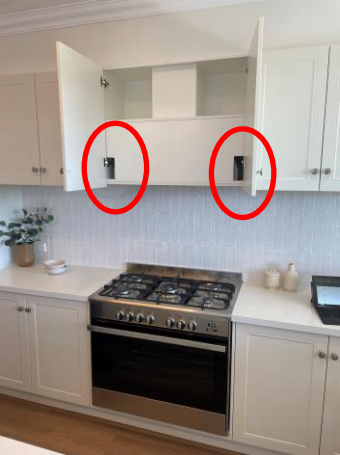
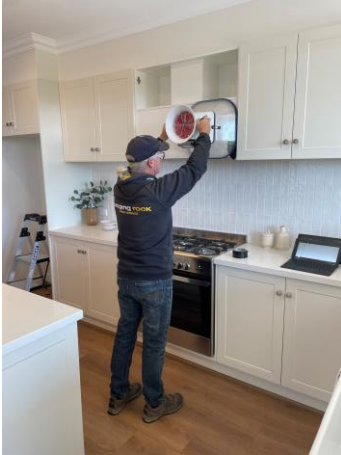
<p>Cabinet around range hood – no leaks</p>	<p>Cabinet around range hood</p>	<p>Measuring leak at holes for door hinges</p>

<p>Measuring leakage of cabinets around an oven</p>	<p>Observing leakage of cabinets around an oven</p>	<p>No solid blocking behind cabinets in another building in the main study. Plastic bags could be sucked from the cabinets into the roof.</p>

Figure 47 Examples of leaks via kitchen cabinetry

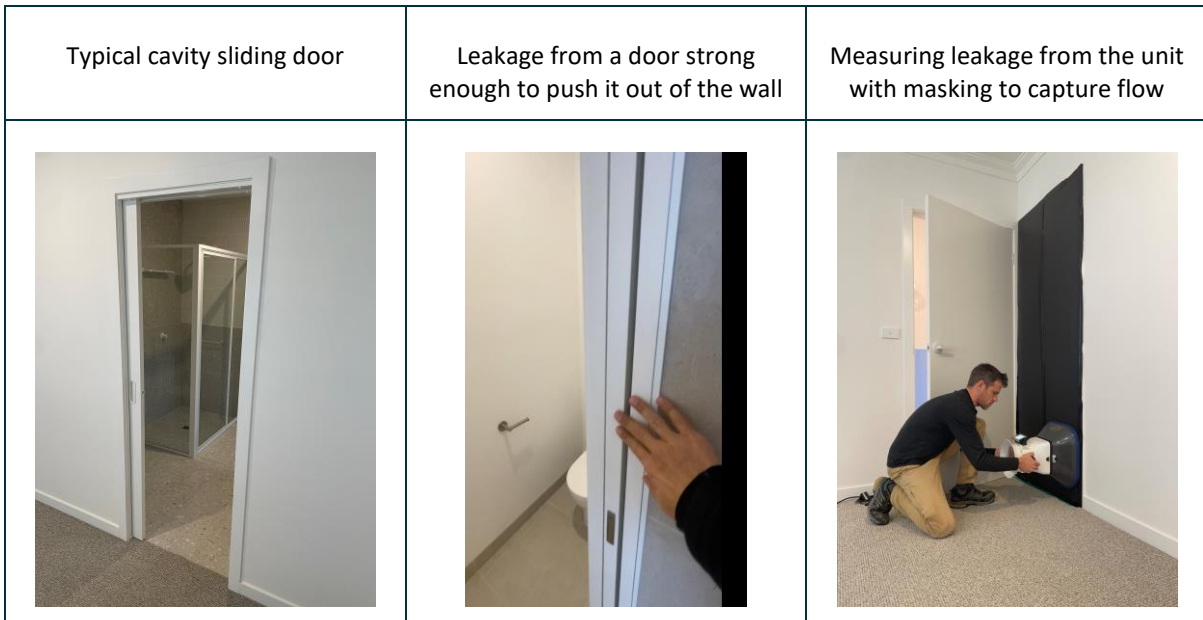
Figure 48 Leakage from cavity sliding doors

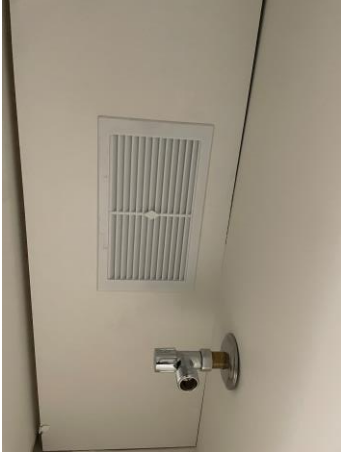
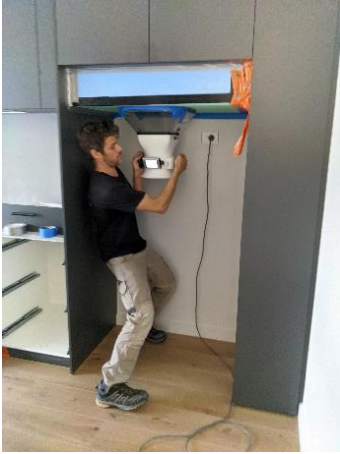
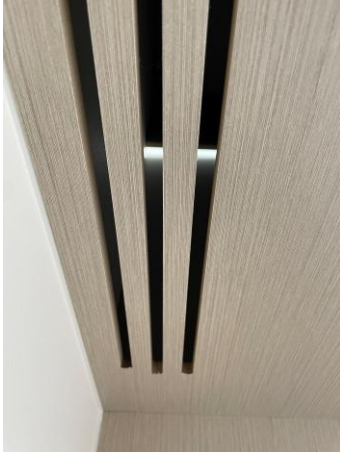
Figure 49 Ventilation holes for refrigerator

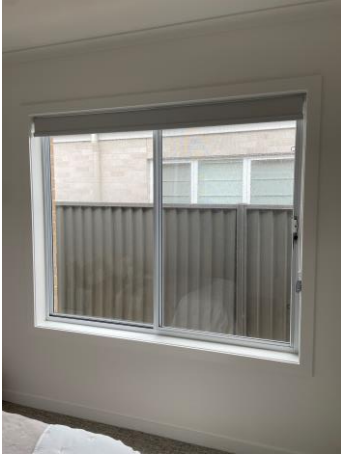
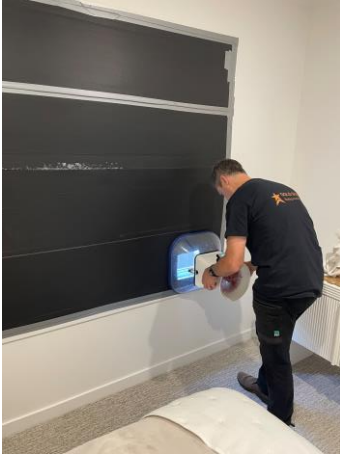
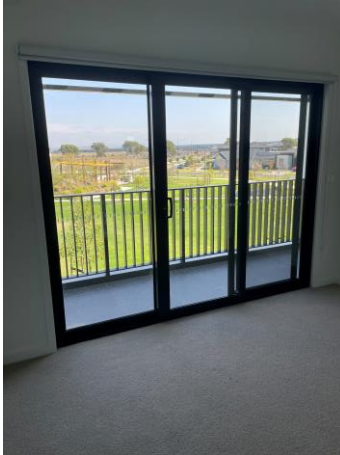
Casement sliding window	Masking and measuring flow from window installation	Sliding doors, not tested

Figure 50 Leakage from window and door units

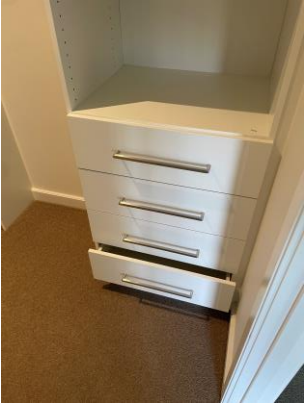
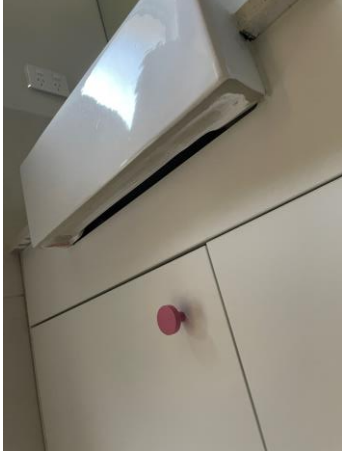
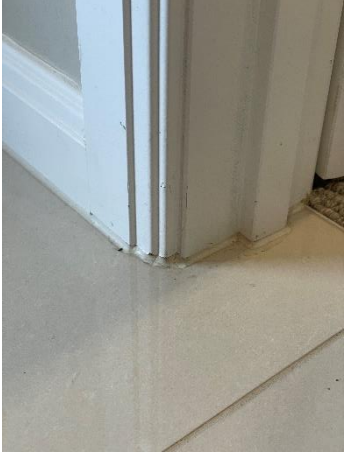
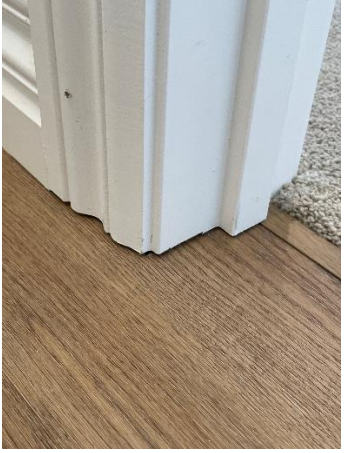
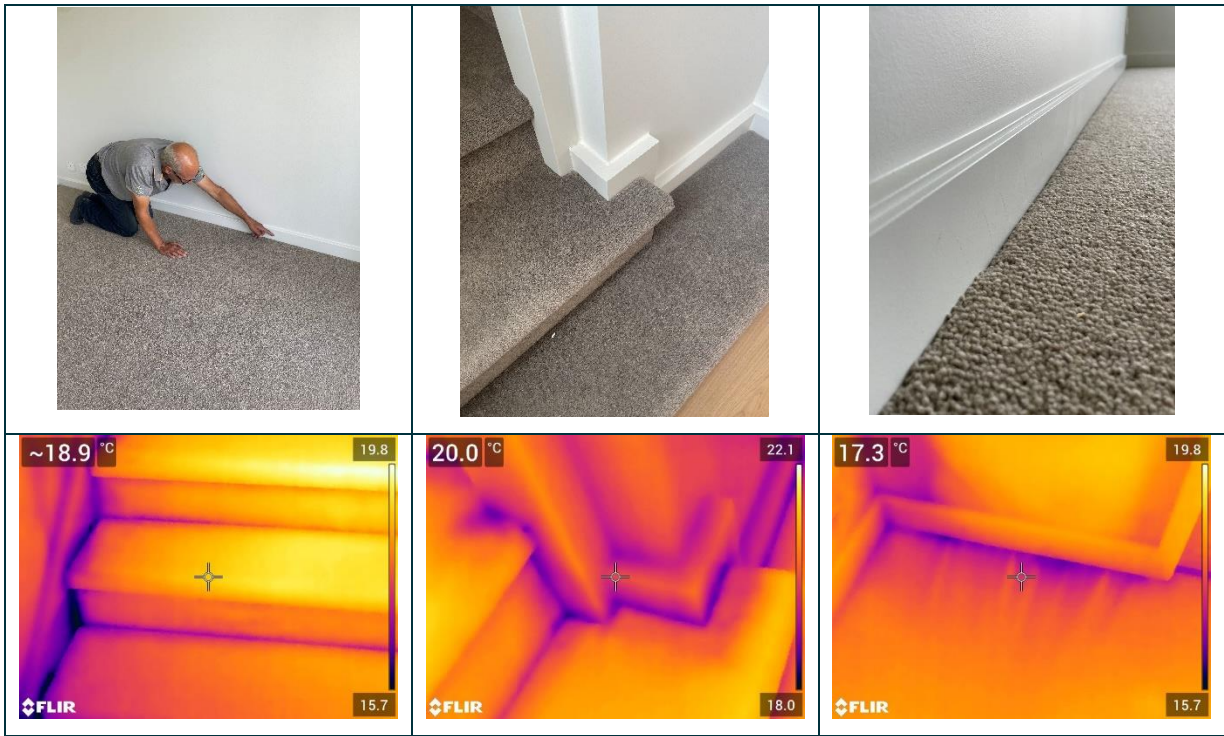
<p>Bathroom cabinet with leak that could not be easily measured</p>

<p>Skirting in one house with seal to floor</p>	<p>Skirting in house next door with no seal to floor</p>	<p>A door leak, not measured.</p>

<p>Leakage along base of wall</p>	<p>Leakage along skirting</p>	<p>Gap was not sealed before carpet was installed</p>

Figure 51 Examples of leakage points identified, but too difficult to measure
