The Environmental Measurement of Residential Buildings

Case Study 2: Concrete Slab-on-ground Floored Residence

Paul Nagle
Department of Climate Change and Energy Efficiency (DCCEE)
Nationwide House Energy Rating Scheme (NatHERS)

Dr Detlev Geard
Dr Mark Dewsbury
School of Architecture and Design at the University of Tasmania

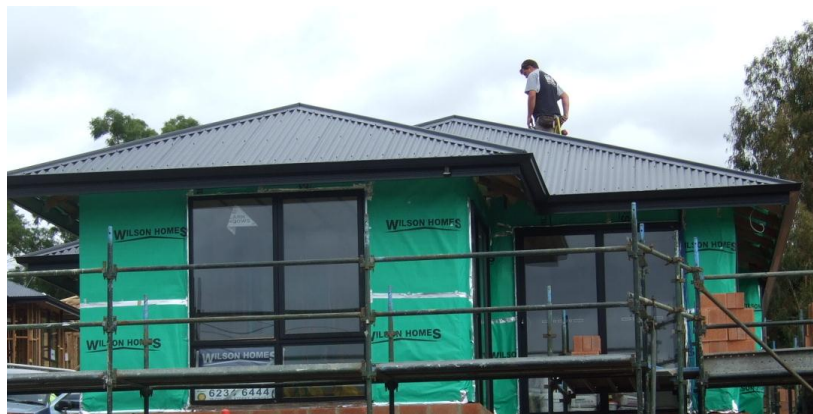
Figure 2.8 - Taping of building wrap at the case study house

Standard building practice required a 150mm overlap of the building wrap at all joints between sheets. To reduce air infiltration and display best construction practice, the building wrap of the case study house was taped at the joints between sheets. The building wrap was also taped around window and door frames, and to the top and bottom plates of the timber wall framing. Figure 2.8 shows the taping of the wall wrapping at the junction of the building wrap.

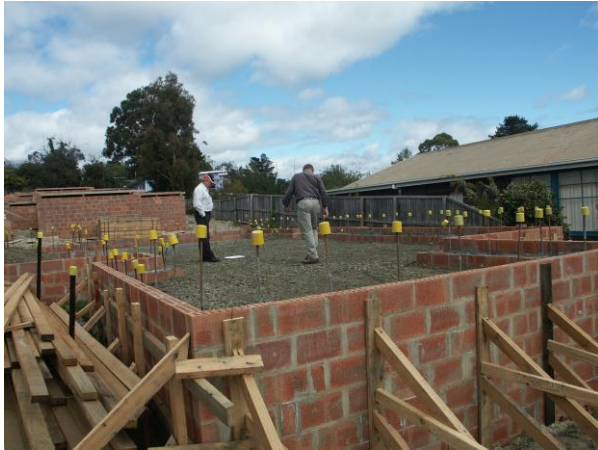
Figure 2.9 – Brick wall and fill preparations for the case study house before concreting

retaining wall for the fill material) and has 400 mm deep internal concrete beams. Due to the slope of the land, the perimeter foundation wall was built to a height of about 1.2m at the front of the house and then filled and consolidated with fine crushed rock. Figure 2.9 and Figure 2.10 show the case study house before and after the pouring of the concrete slab.

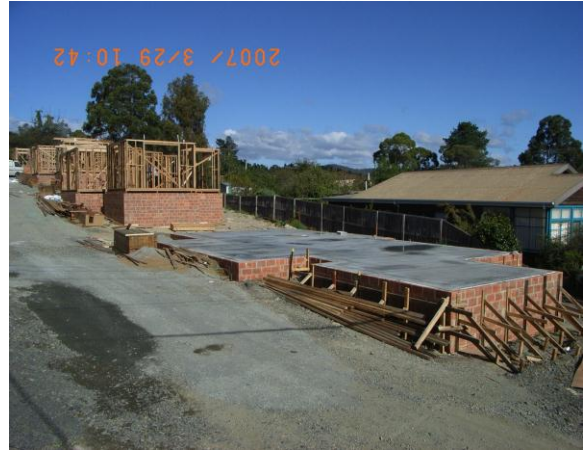
Figure 2.10 - The case study house after the concrete floor has been poured and finished

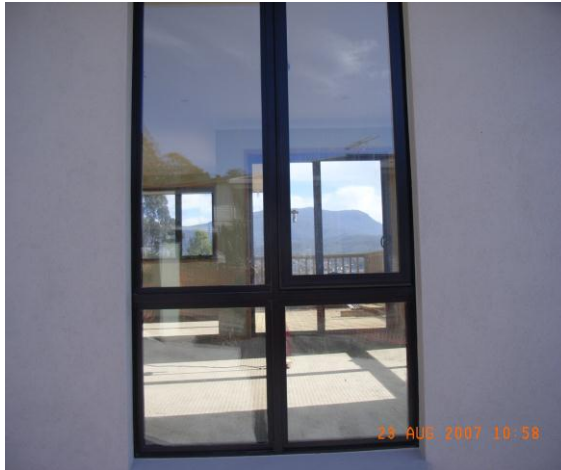
Figure 2.12 – Aluminium framed awning window from the case study house

All external sliding doors and windows were manufactured by Brednams and supplied by Clark Windows, Smithton, Tasmania. Figure 2.12 shows the living room awning window and Figure 2.13 depicts the window certification of the window.

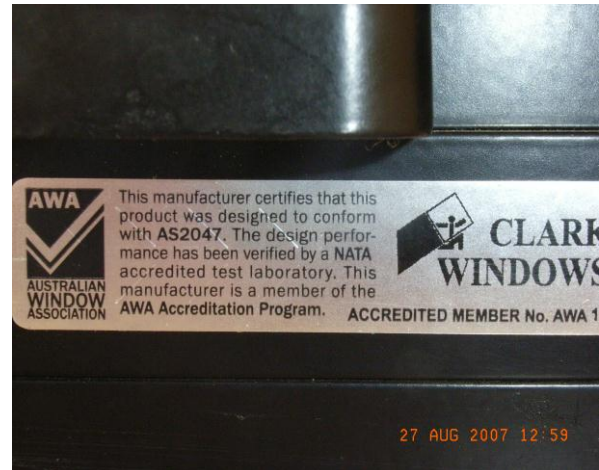
Figure 2.13 – Aluminium framed window label showing accreditation

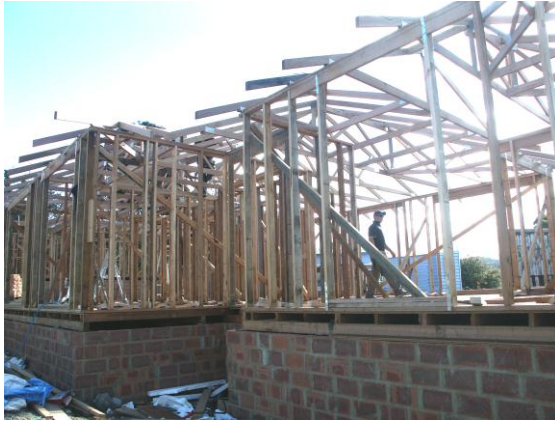
Figure 2.14 - Installation of timber roof trusses onto the exterior stud wall

The 10mm paper-faced gypsum plasterboard ceiling lining was attached to steel furring channels, which were fixed to the underside of the roof trusses. Figure 2.14 and Figure 2.15 show the installation of the roof trusses at the case study test house. The case study house had R4.0 fibreglass batt insulation installed over the entire ceiling area.

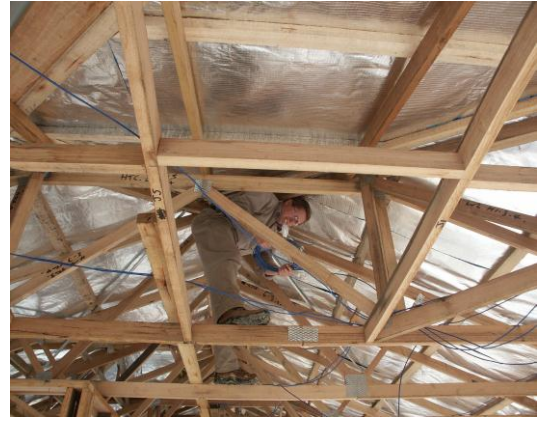
Figure 2.15 - Interior view of the roof trusses and reflective sarking

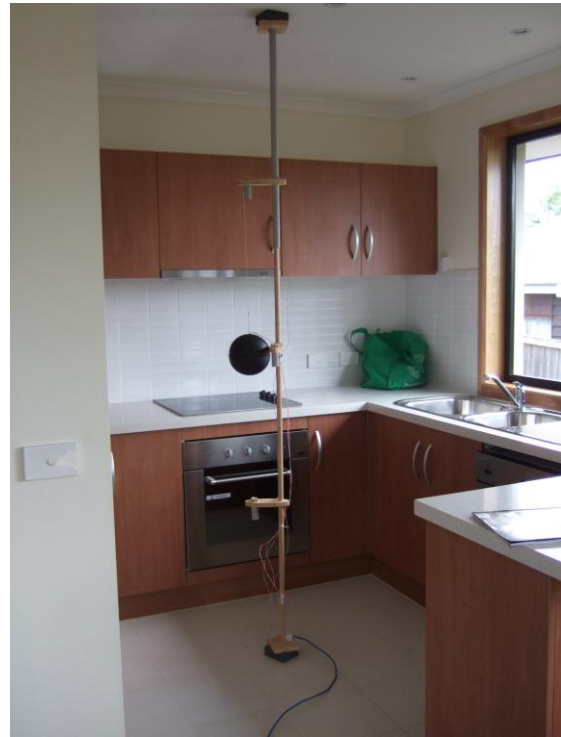
Figure 3.3 – Photograph of pole installed in kitchen

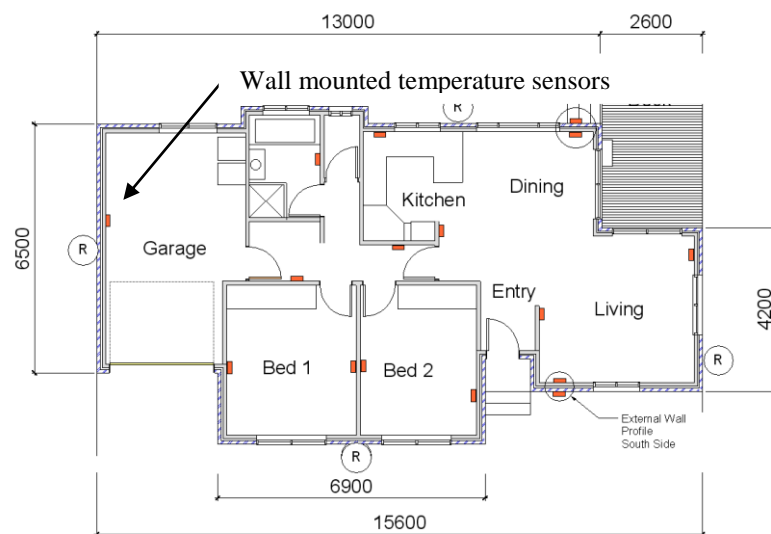
Figure 3.5 - Location of permanent temperature sensors attached to the walls at a height of 1200mm from floor level

location of the wall mounted sensors is shown in Figure 3.5. Figure 3.6 shows the wall temperature sensor's housing, which was attached to two walls in each room of the house.

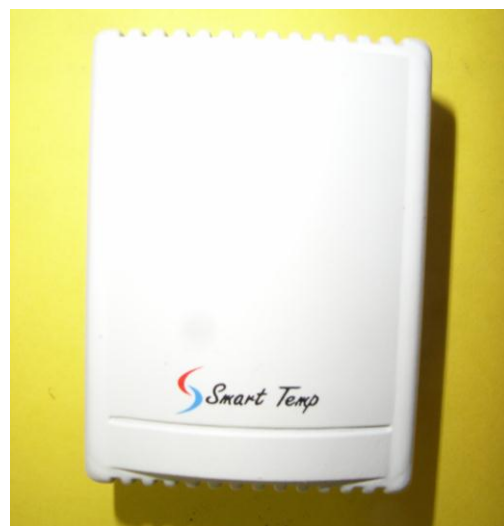
Figure 3.6 – Wall-mounted sensor at the case study house

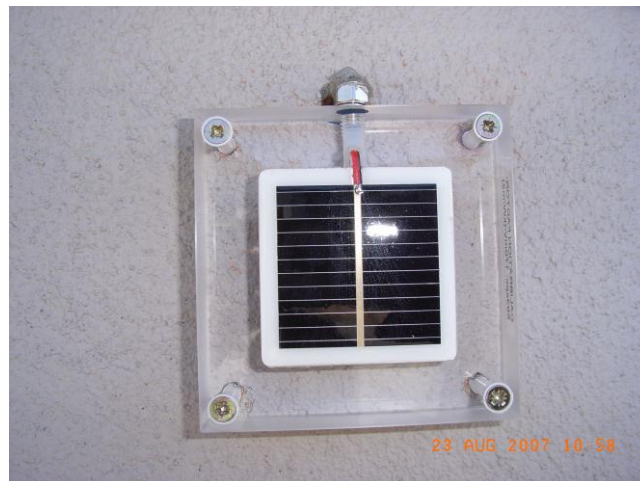
Figure 3.9 - SolData 80 SPC pyranometer fixed external walls of the case study house to measure solar radiation on the wall

One of the many measurements taken included the temperatures of the individual brick veneer wall components, that is, from the inside surface of the plasterboard wall to the exterior surface of the brick veneer wall. Temperature sensors were installed within the north-west and the south-east wall sections to measure the heat flow through the horizontal wall section of the house as shown in Figure 3.8. In addition, vertical solar radiation was measured on all four sides of the house, at a height of 1.2m from the internal floor level as shown in Figure 3.9.

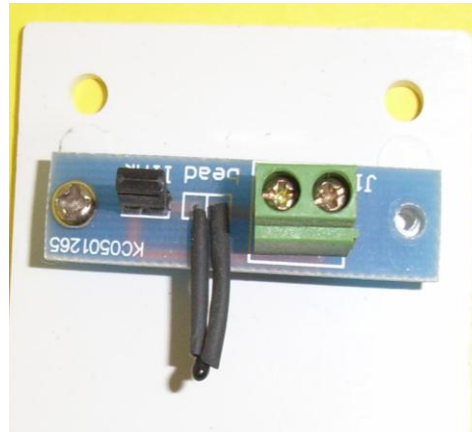
Figure 3.10 - AD 592 CN temperature sensors attached to wall plate at the wall

Figure 3.10 and Figure 3.11 show the AD592CN temperature sensor installed at the wall of and at the centre of the rooms at three different height levels for the recording of dry bulb air temperature.

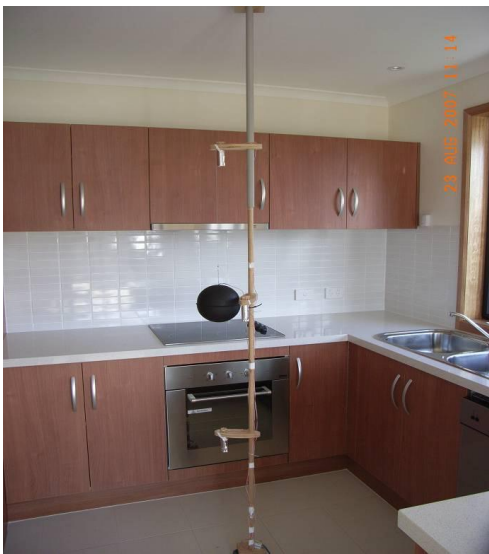
Figure 3.12 - Timber pole with temperature sensors located at different height levels

Dry bulb temperatures were measured at various heights in the centre of internal rooms, the roof space and the subfloor space. To support and fasten off the sensors at the centre of the different zones, an adjustable pole system was constructed, which allowed for easy adjustment to suit the height requirements of the sensor devices. This pole system comprised: a 20mm diameter timber pole, a 25 mm plastic electrical conduit and square top and bottom plates. Figure 3.11 illustrates the detail of the temperature sensor affixed to the timber poles at the centre of the zones. Three oval timber arms were fixed to each pole with hot glue at heights of 600mm, 1200mm and 1800mm from floor level (Figure 3.12). Dry bulb temperature sensors were then installed inside the electrical conduits and attached to the oval timber arm. Where the sensor conduit faced direct solar radiation, the plastic conduit was covered by reflective foil (Figure 3.13).

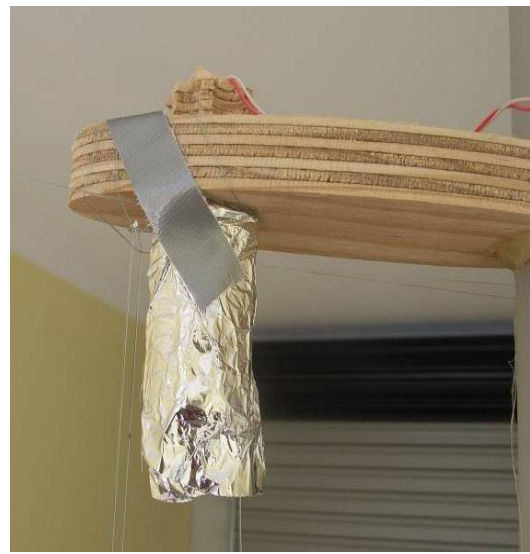
Figure 3.13 - Temperature sensor fixed inside a plastic pipe, covered by reflective foil

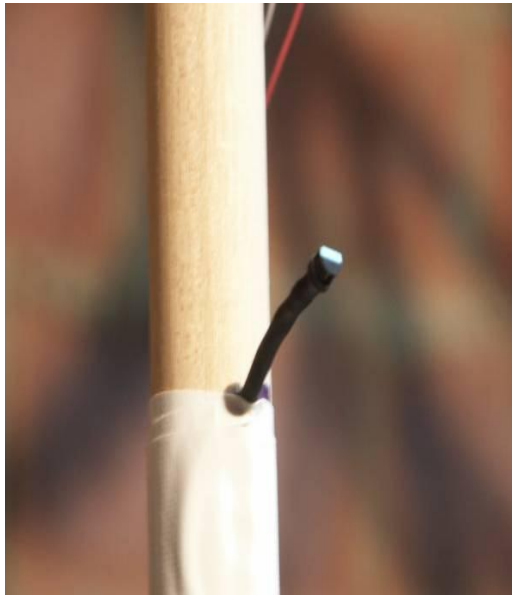
Figure 3.18 - Temperature sensor fixed to pole at mid roof space

Dry bulb temperature was also measured in the middle of the roof space. The temperature sensor was fixed to a timber pole using white cotton tape as shown in Figure 3.18. This figure shows the timber pole located in the roof space of the case study house with the temperature sensor attached to the pole.

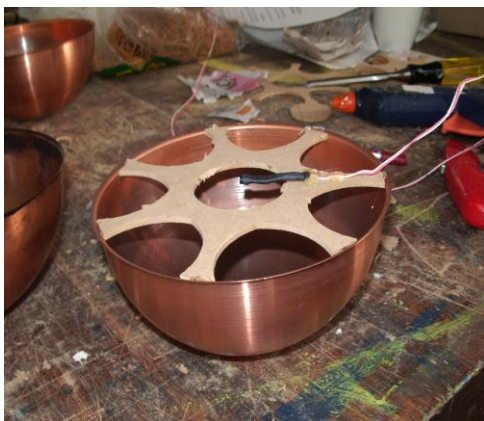
Figure 3.30 - Inserting the air temperature sensor into the globe half sphere

Copper globe thermometers were installed in each room, to measure a combination of dry bulb air temperature and mean radiant temperature. The globe thermometers were installed to study the relationship between dry bulb air temperature and the environmental temperature in each room. The globe thermometers were made according to the ASHRAE 2006 specification. They consisted of a 150mm diameter hollow copper ball, coated with a matt black paint and an AD592CN temperature sensor was fixed within the centre of the sphere. Figure 3.30 shows the air temperature sensor being attached within the centre of the copper ball, while Figure 3.31 shows the completed globe thermometer attached to the timber pole at a height of 1200mm from the floor level.

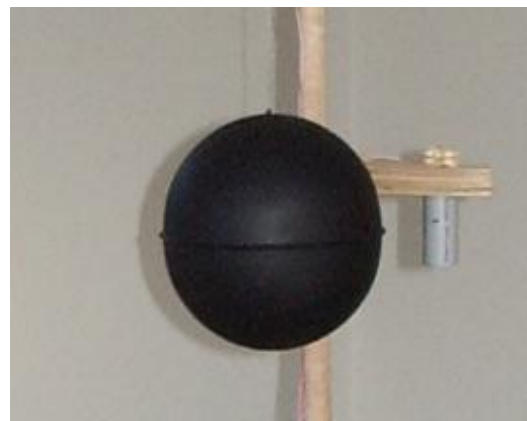
Figure 3.31 - Globe thermometer installed and measuring environmental temperature

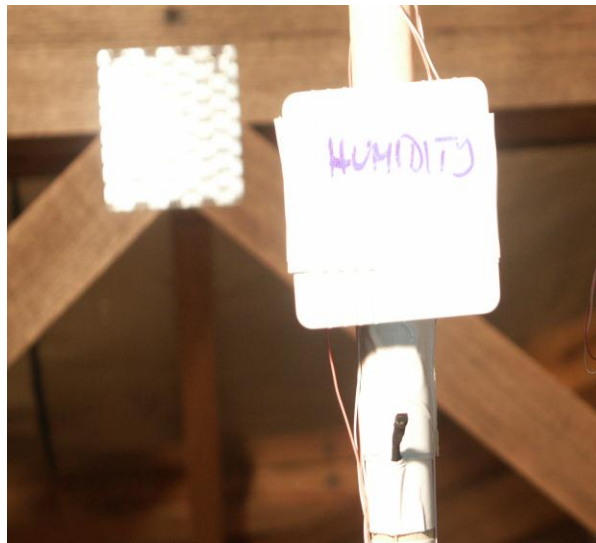
Figure 3.32 - Humidity transmitter installed in the ceiling space

The Vaisala HMW40 humidity transmitter was chosen because of input requirements and output style. The operation range is between 0 and 100% relative humidity, with a measurement of uncertainty of $\pm 3\%$ @ $+20^{\circ}\text{C}$. Figure 3.32 shows the installation of the humidity transmitter within the roof space of the case study house. The humidity transmitters were located at mid-height of the roof space in the case study house. The transmitters were attached to a timber pole with glue and a white cloth tape. The collection of the humidity data in the roof space of the case study house was not part of the validation process, but was collected for further thermal performance research analysis.

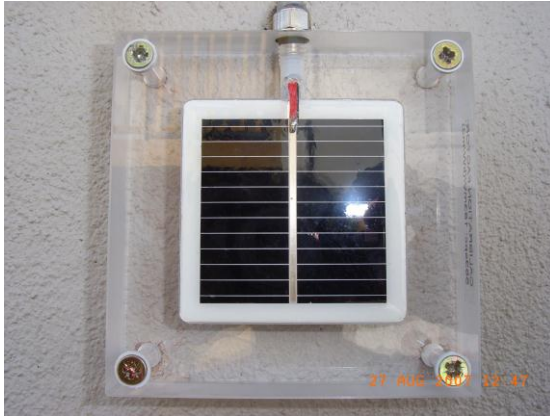
Figure 3.33 - SolData 80SPC pyranometer fixed to an external wall

calibration factor using the required equation ($S=U/K$) to achieve actual irradiation values (W/m^2). Figure 3.33 shows the pyranometer attached to the external wall of the house and Figure 3.34 shows the horizontal and vertical fixed positions of the pyranometers for the site weather station.

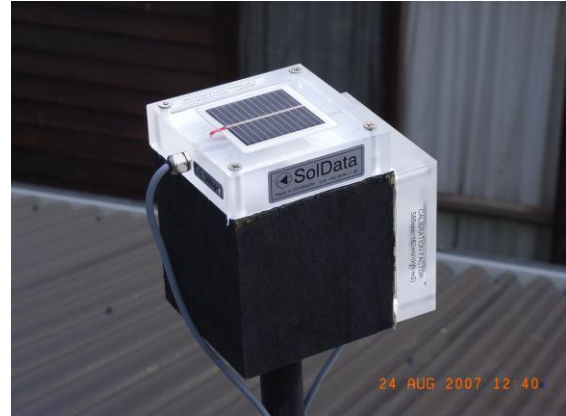
Figure 3.34 - SolData 80SPC pyranometers installed as part of the site weather station

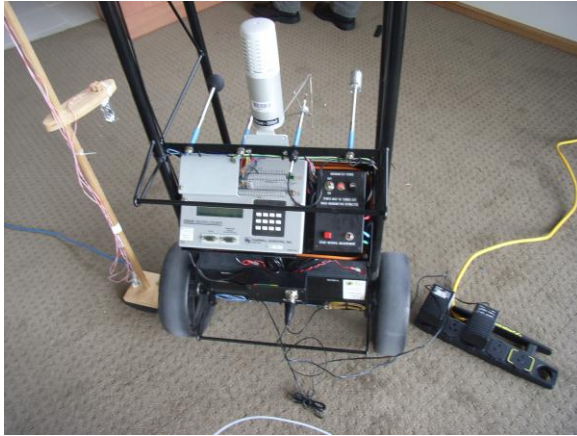
Figure 3.35 - Comfort cart measurement equipment

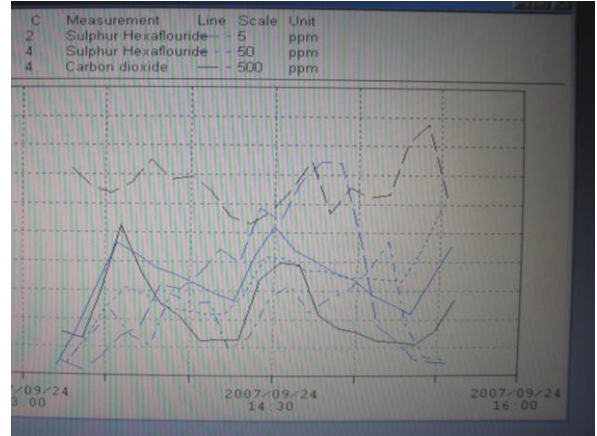
Figure 3.36 - Tracer gas computer graph

The tracer gas method involved the introduction of gases at a high concentration level to the measured spaces. Carbon Dioxide (CO_2) into the roof space and Sulphur Hexafluoride (SF_6) into the interior of the test house. The decay of the gases was observed and specific methods were then used to calculate the air change rate per hour (ACH). Figure 3.35 shows the MABEL comfort cart which was used in conjunction with the tracer gas and blower door tests for the case study house. Figure 3.36 shows the tracer gas decay graph from the computer during time of testing.

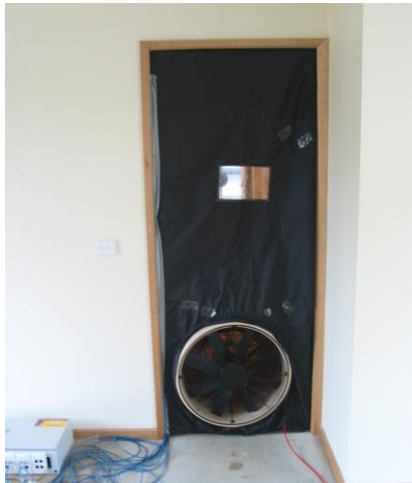
Figure 3.37 - Interior view of the blower door equipment installed in the case study house

The blower door test was conducted twice using a pressurisation fan, which was conducted twice. In the first test the fan was attached to the front door (living room) and in the second test it was attached to the door between the garage and the hallway. In both cases, the interior of the house was pressurised in stages to 4, 8, 20 and finally, 50 Pa and the infiltration rates were accordingly measured. Figure 3.37 shows the installation of the blower door test unit and Figure 3.38 the blower door pressurisation fan.

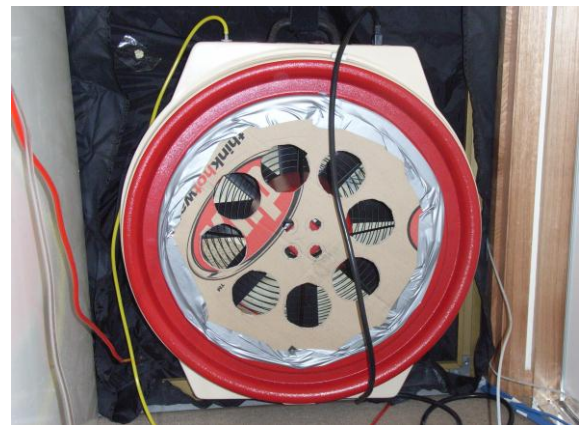
Figure 3.38 - View of the pressurisation fan of the blower door equipment

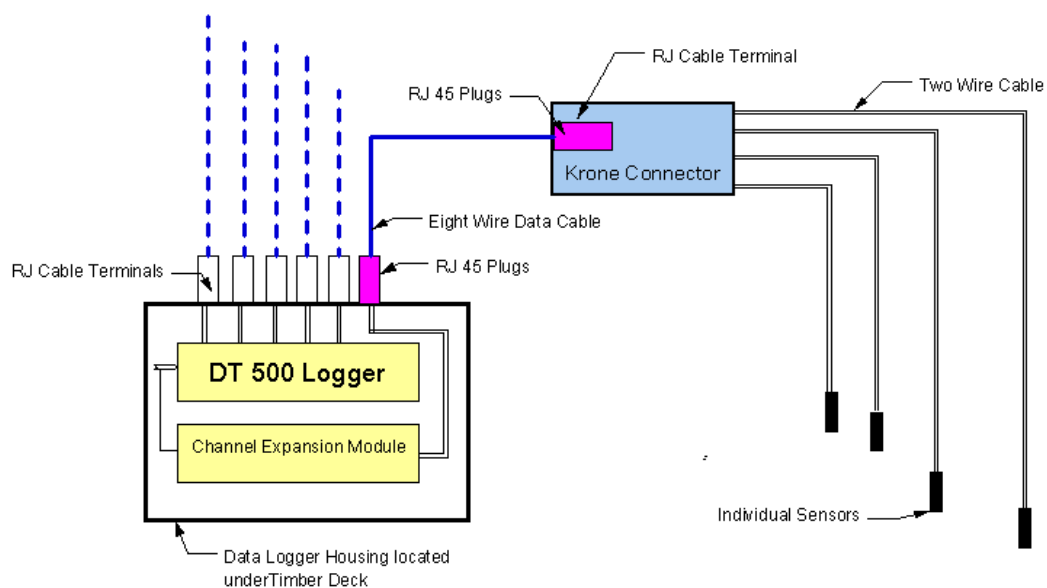
Figure 3.39 - Wiring diagram for the cabling and wiring connection between the data logger and the individual sensors

Figure 3.39 illustrates the wiring concept of the measuring equipment, starting from the data logger with the eight wire data cable connected to the Krone connector plate with a RJ 45 plug and continuing from the Krone's bell wire connection, leading to the individual sensors installed around the house.

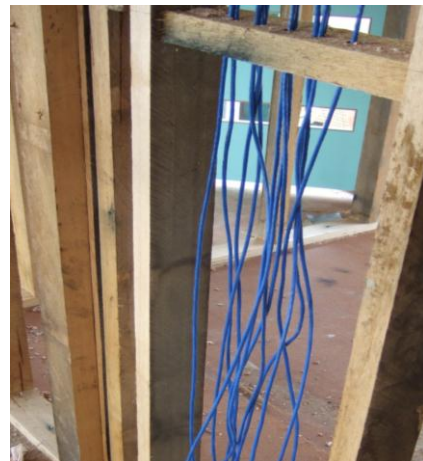
Figure 3.41 - Installation of data cables in hallway wall

Figure 3.40 to Figure 3.45 show several key wiring and connection details. Figure 3.40 shows labelled AD592CN sensors with bell wire leads attached before installation into the brick veneer wall. Figure 3.41 depicts the data cables installed within the hallway's wall cavity, connecting the data logger to the sensors, via the Krone connectors in the roof space. Figure 3.42 shows the installation of the Krone connectors, providing the link between the data cables, from the data logger and the bell wire and individual sensors. Figure 3.43 shows the Krone connectors in the roof space fixed to the roof trusses with the data cable and bell wire connections. Figure 3.44 shows all the data cables connected to the data logger with RJ 45 plugs. Finally, Figure 3.45 shows the data logger and the interior wiring connection of the data cables to the RJ 45 cable terminals in the metal box.

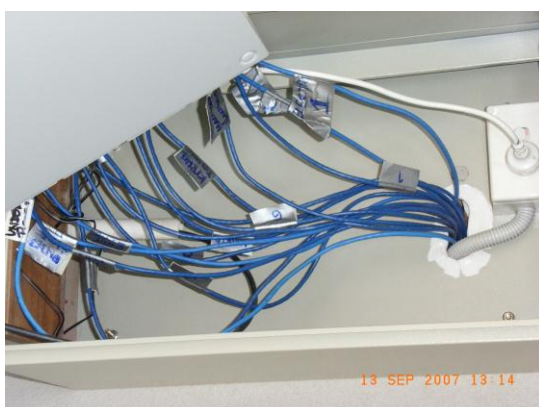
Figure 3.44 - Data cable coming out of wall and connecting to data logger with RJ 45 plugs

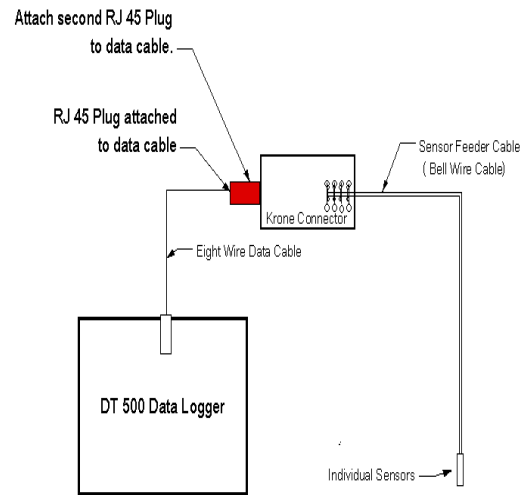
Figure 3.47 - Step 2. Attaching second RJ 45 plug to data cable

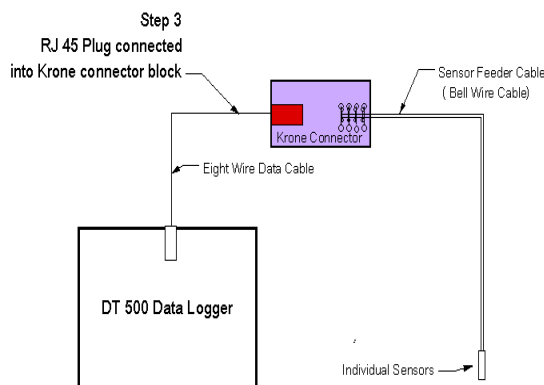
Figure 3.48 - Step 3. Connecting the RJ 45 plug into the Krone connector

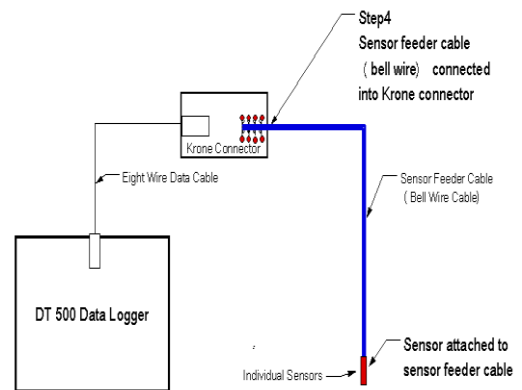
Figure 3.49 - Step 4. Connecting the sensor feeder cable into the Krone connector

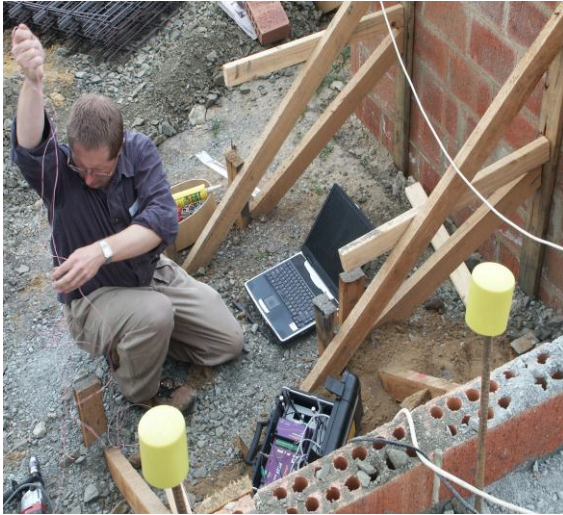
Figure 3.50 - Connecting and checking sensor feeder cable on site

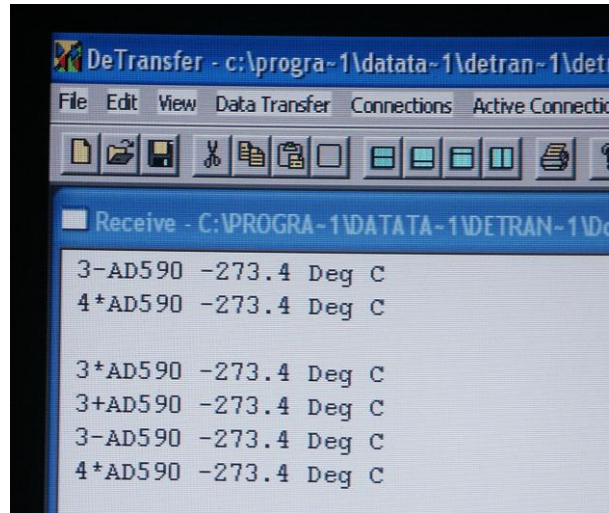
Figure 3.51 - Checking cable connection and data logger's zero value readouts

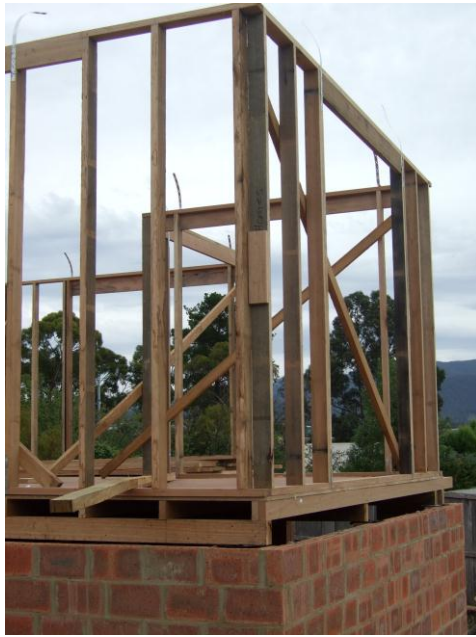
Figure 4.1 - Corner detail at the framing stage of one of the platform floored houses

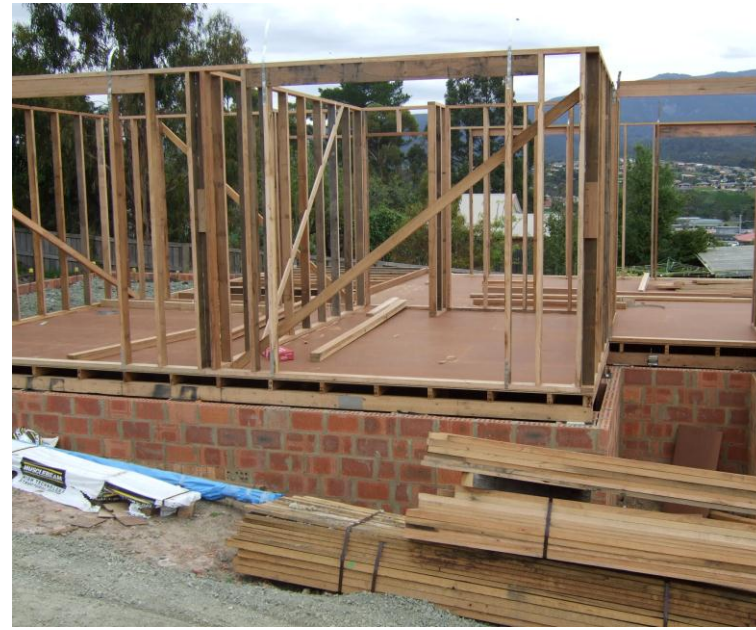
Figure 4.2 - Framing stage of the test house of one of the platform floored houses

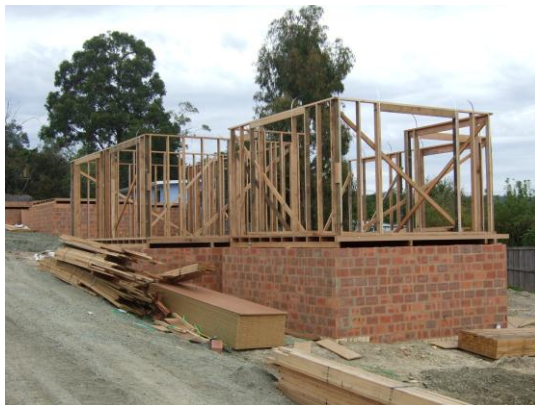
Figure 4.3 - Completed wall-framing stage of one of the platform floored houses

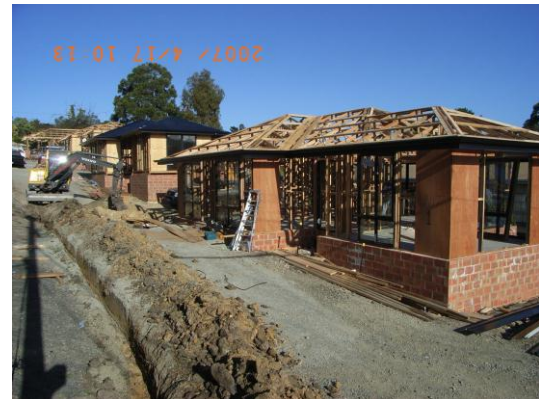
Figure 4.4 - Framing stage of the concrete slab test house

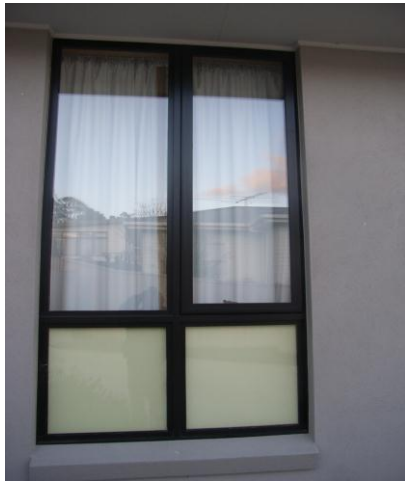
Figure 4.7 - Window frame detail for the bedroom window

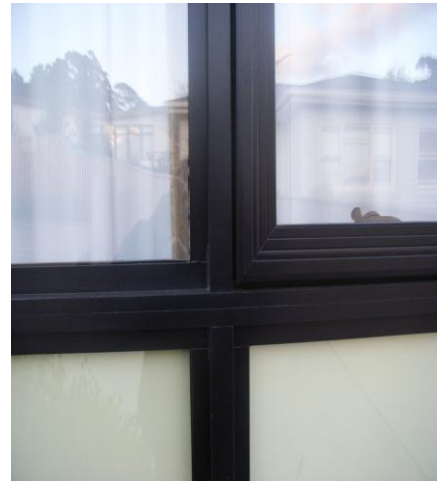
Figure 4.8 - Close up image of window framing

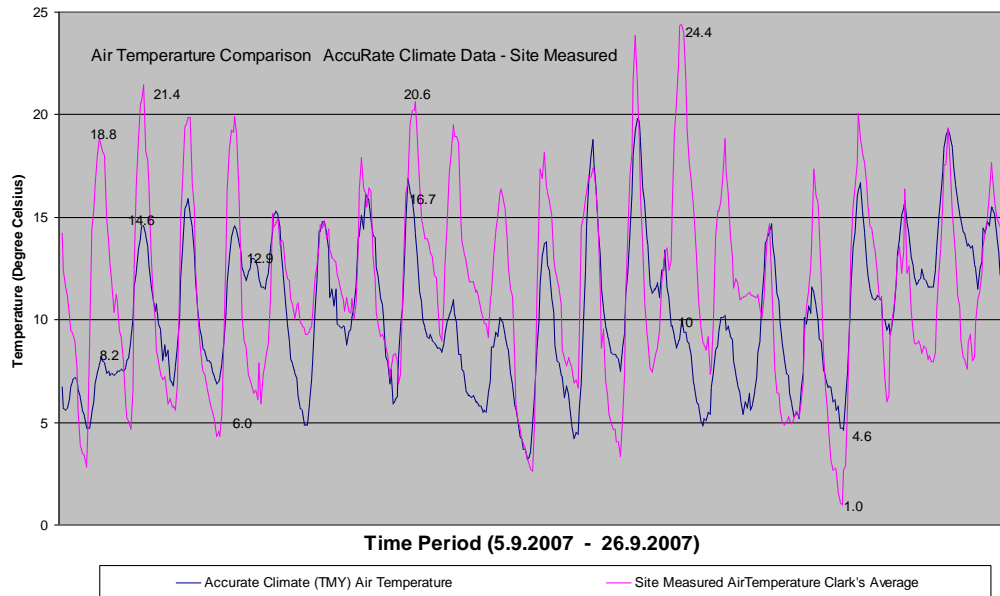
Figure 5.1 - Temperature comparison between site-measured and TMY air temperature values

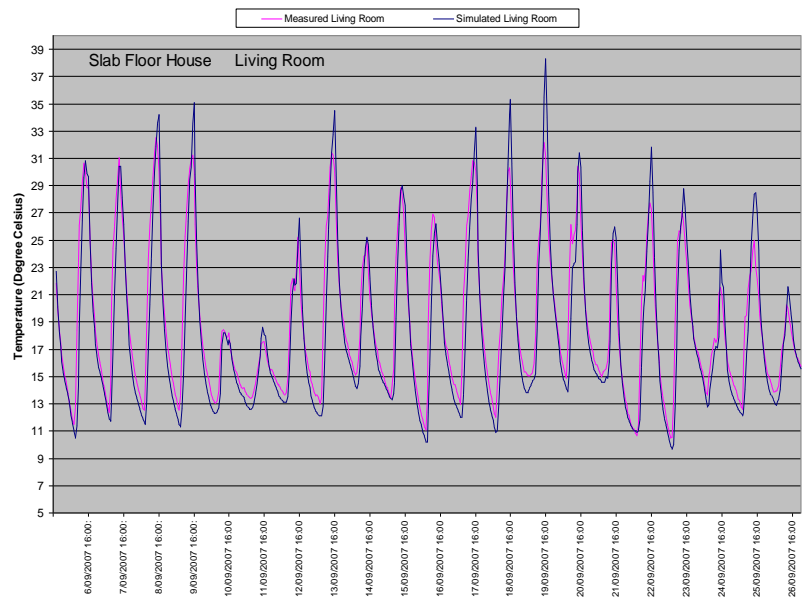
Figure 5.2 – Graphical time series comparison of simulated and measured zone temperatures

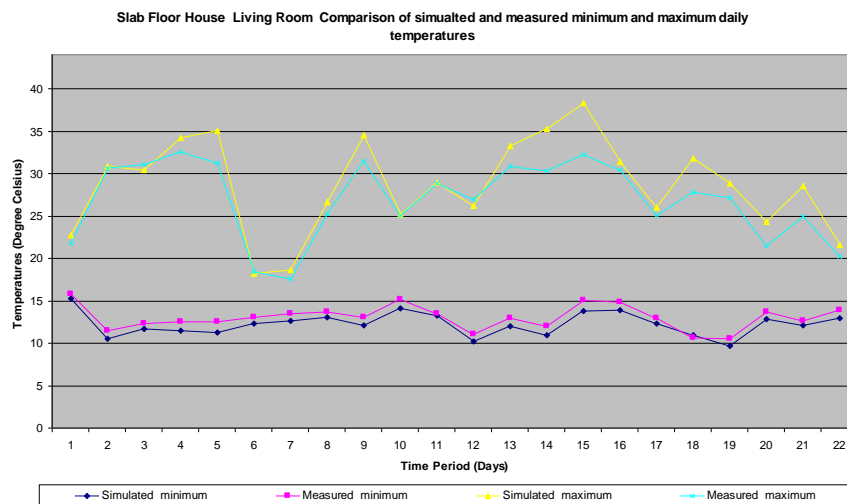
Figure 5.3 - Graphical time series comparison of simulated and measured maximum and minimum zone temperatures

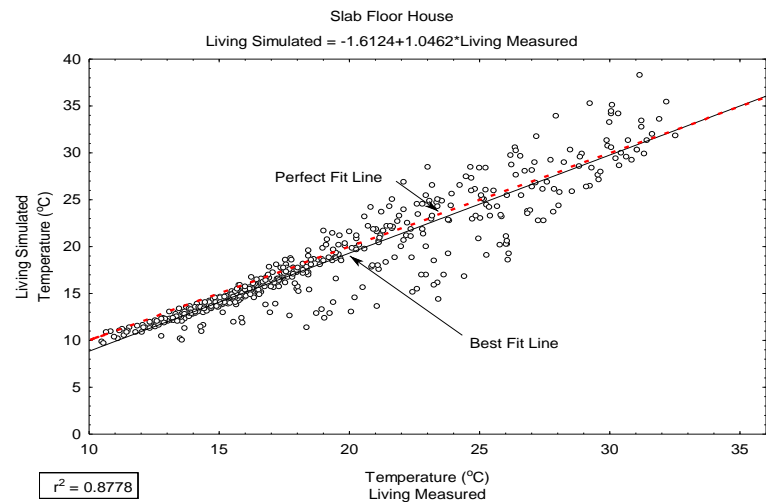
Figure 5.4 – Scatter-plot of simulated and measured zone temperatures

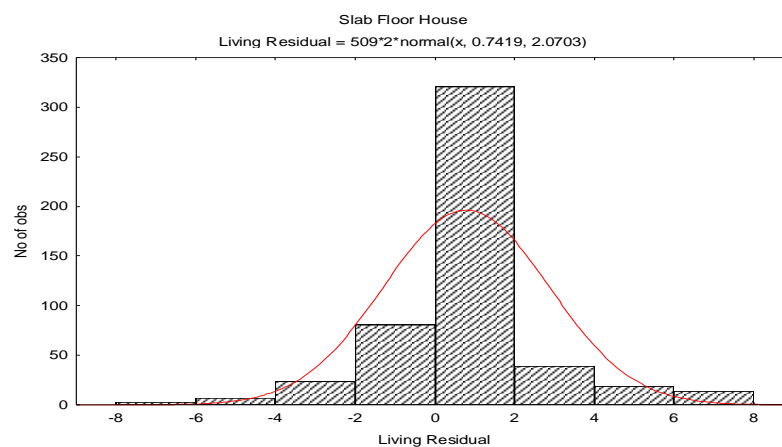
Figure 5.5 – Histogram showing distribution of zone residual values

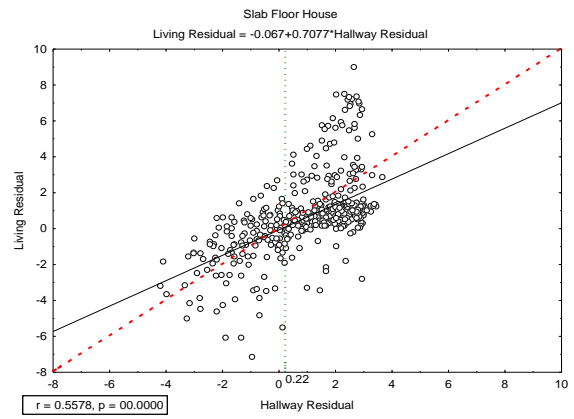
Figure 5.7 - Scatter-plot 2 of adjoining zones

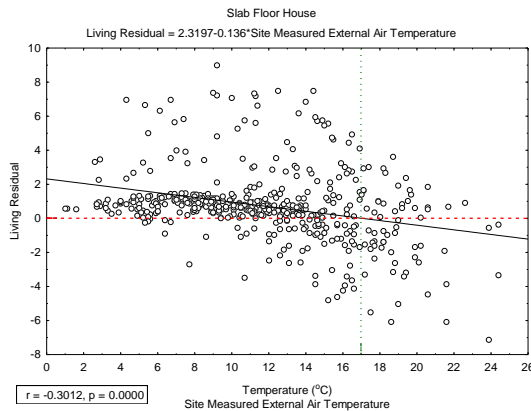
Figure 5.8 – Scatter-plot of zone residual values and external air temperature

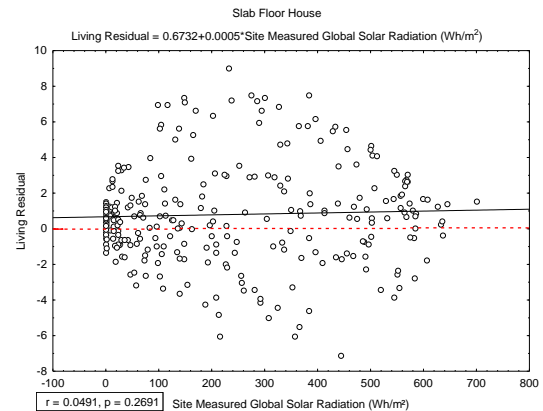
Figure 5.9 – Scatter-plot of zone residual values and global solar radiation

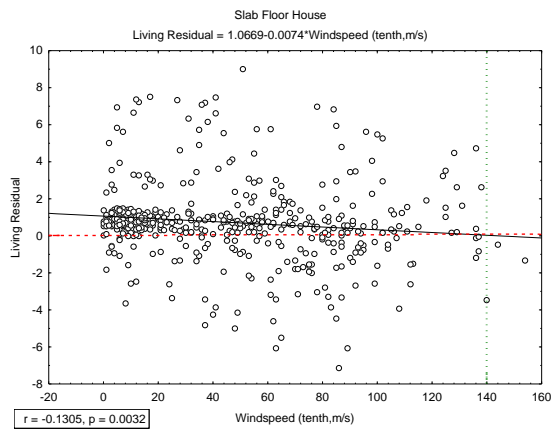
Figure 5.10 – Scatter-plot of zone residual values and site wind speed

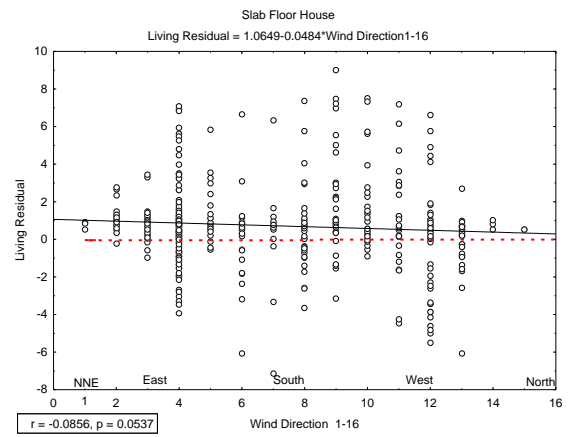
Figure 5.11 – Scatter-plot of zone residual values and site wind direction
